Survey by Cooke and Kettyle

SECTION 1

1.00 SCHEME OBJECTIVES

SECTION 2
CONDITION REPORT
AND
PROPOSALS

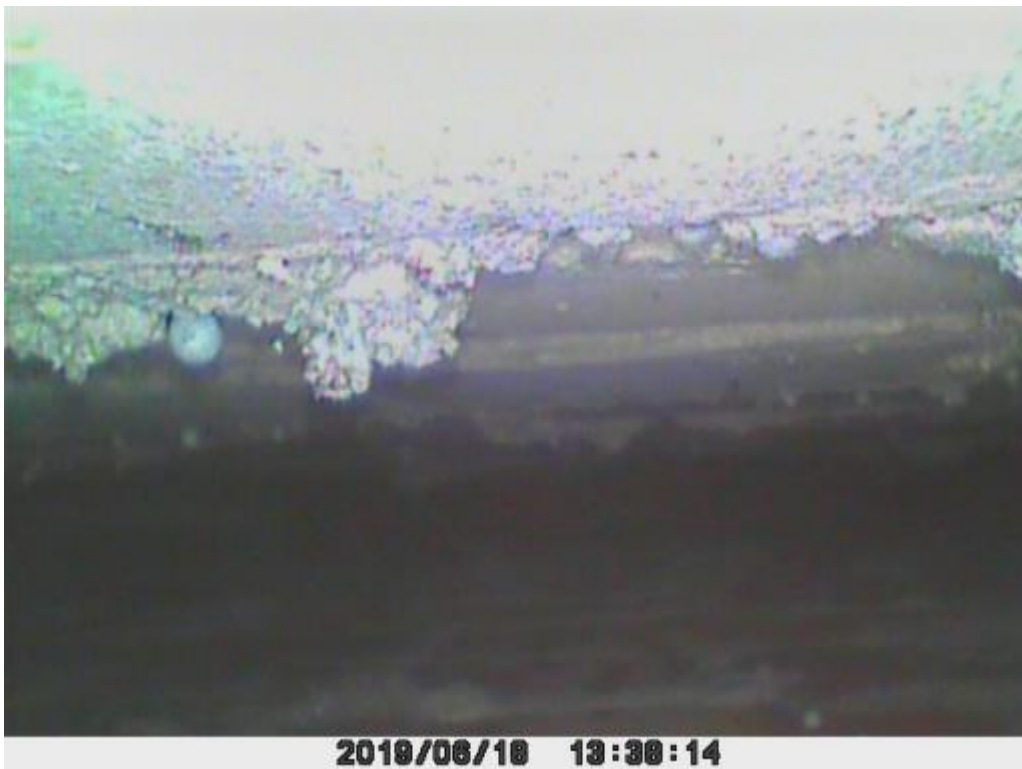
Walls to all blocks have been drilled at various levels to allow checking of the existing cavity insulation with a boroscope. The findings are that, at Rossmore Green, there is a mixture of different types of insulation to the cavities with some white beads having been used and some blown fibre evident, in all other instances the walls have been insulated with white polystyrene beads. In all cases areas of missing cavity insulation were observed. Refer to typical photographs 13 to 15 which were taken within the wall cavity. This was the case at both high and low level in the wall elevations. Insulation has settled and boroscope inspections indicate areas of the cavities that have no insulation present.

Figure 14 [REDACTED] – Glassillan Grove – Insulation absent

The remnants of the existing blown fibre or bead cavity insulation will be mechanically removed by a BBA accredited cavity clean specialist. Cavities will be allowed time to dry and refilled with an approved expanded polystyrene bonded bead cavity wall insulation by a registered installer (BBA accredited) and a Cavity Insulation Guarantee Agency (CIGA) guarantee obtained.

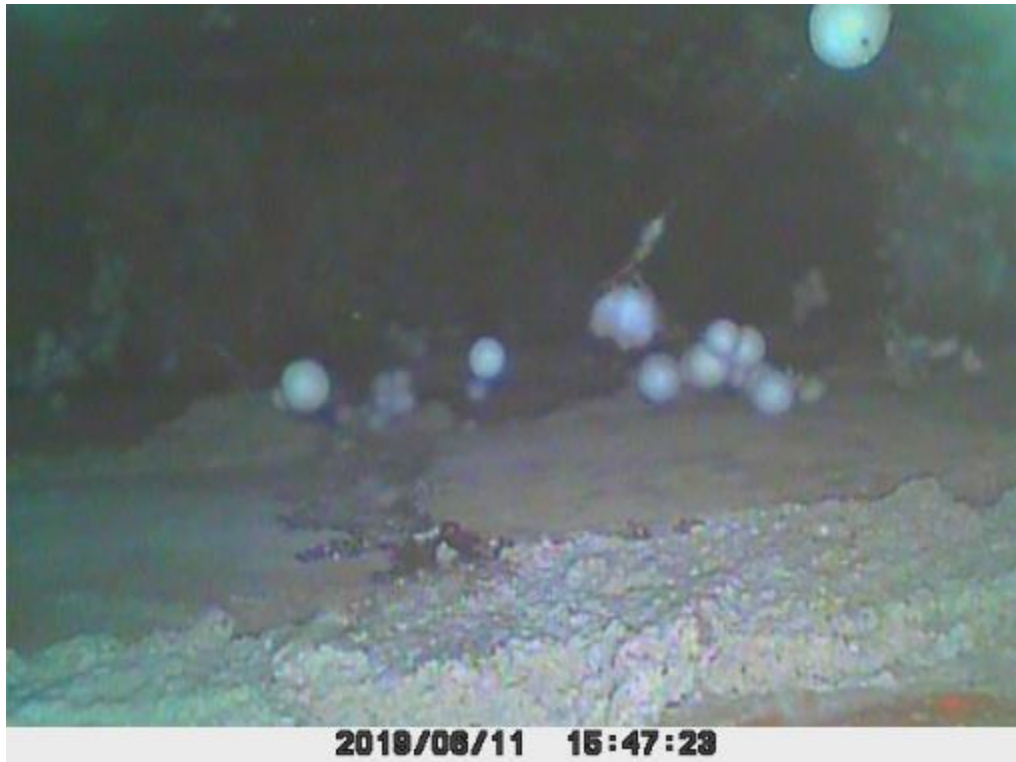
Figure 15 Rossmore Green - Void in insulation

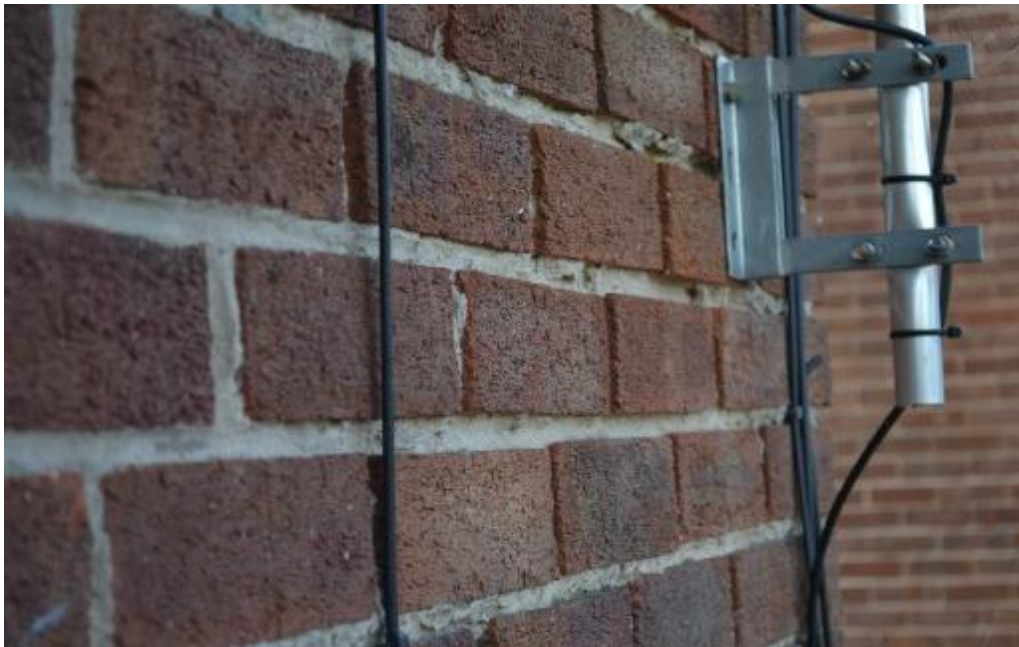
It could also be the case that insulation may not have been installed correctly or that it could have been installed in the 1980's when industry standards were not as advanced as they are today. The mortar pointing to the existing brickwork is badly weathered with areas of pointing having lost its struck joint and the softer more porous jointing bed being exposed. A mortar fillet has been provided at reveals of windows and external doors.

Figure 16 Poor mortar pointing to the existing brickwork

Brickwork, where covered in moss or water stained, will be cleaned to remove moss and staining (260m²) and treated with a biocide. All brickwork will be repointed (3980m²) in accordance with the NIHE Specification. A masonry water repellent will be applied (3980m²). Mortar fillets will be provided to all window and door reveals.

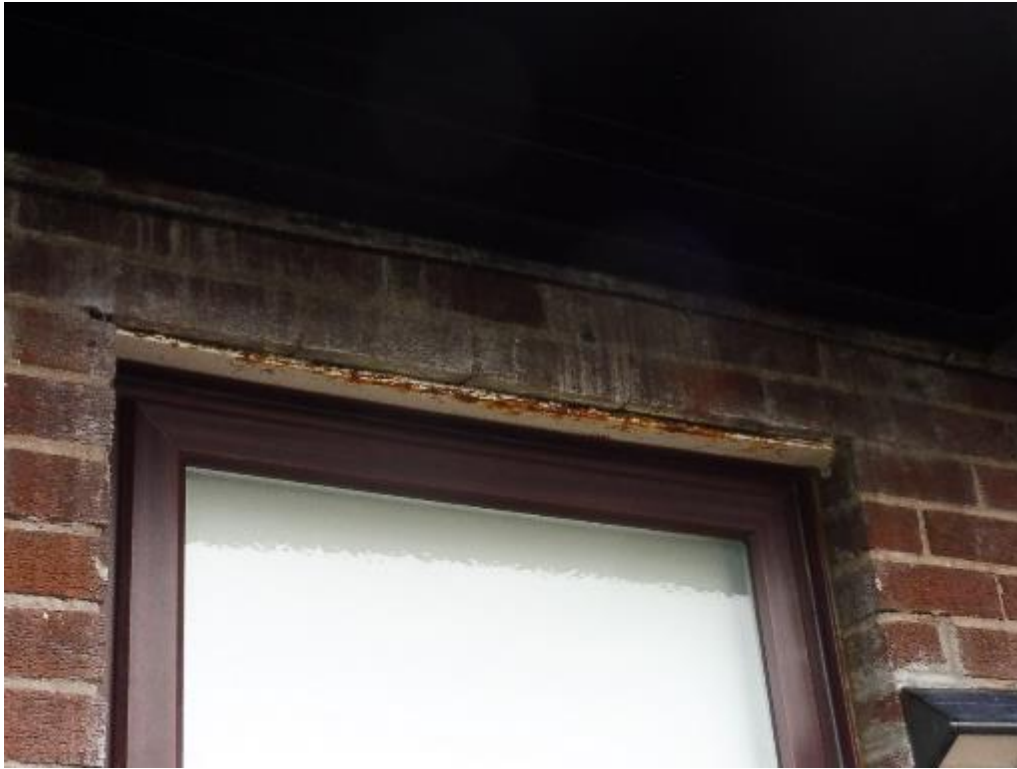
Steel angle lintels over windows and doors have rusted in numerous positions due to the water ingress as described in section 1.01 above. These lintels are now affected by ferrous oxide which is causing the steel to expand and widen the joints within the surrounding brickwork.

Figure 17 Steel angle irons affected by rust

Steel lintels will be replaced where affected by rusting. This will entail cutting out the existing steel lintel together with the end brickwork and the brickwork courses carried by the lintel. It is proposed to use a stainless steel lintel together with a rigid plastic cavity type cavity damp proof course with end closers and weep holes fitted above the lintel, the brickwork above the lintels will be built up using the salvaged existing bricks to maintain the existing appearance as far as possible. (118Nr)

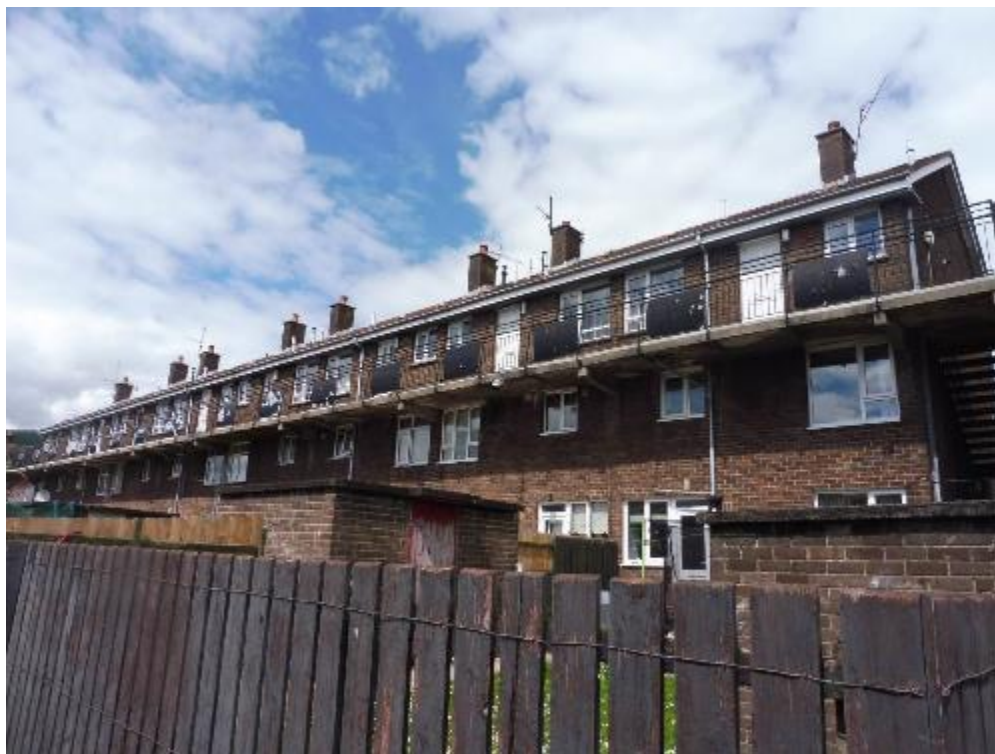
A concrete balcony exists at second floor level of this block to access the flats which are above the maisonettes at Rossmore Green. This balcony appears to form part of the reinforced in-situ concrete floor slab separating the flat from the maisonette. The balcony is asphalt coated but the asphalt is in poor condition with cracks evident. Leaks are occurring through the cracks in the asphalt as evidenced by the water ingress to the first floor ceilings in some of the maisonettes (see photographs 26 and 27) with areas of water staining, mould evident and water running down the internal face in severe instances. It appears that rainwater is penetrating the concrete balcony at the defective asphalt skirting and by capillary action is being carried across the cavity wall by the concrete floor which appears to bridge the cavity wall into the first floor of the maisonettes below. It is also possible that wind-blown rainwater from the soffit of the concrete balcony is running onto the wall and is being carried across the cavity. The balustrades to these balconies have a mixture of panels of railings and solid curved panels. The curved panels are considered unsightly.

Figure 20 Concrete balcony to Rossmore Flats

It is proposed to remove and replace all asphalt with an isolating membrane and 20mm asphalt including upstands, drips, channels, etc. The upstand at the outer edge of the balcony will be replaced and a GRP edge trim provided to create a drip. An upstand will be provided at each door threshold. The solid curved panels within the handrails will be replaced with panels of railings and all metal railings will be repainted, balustrades can remain in-situ throughout the works.

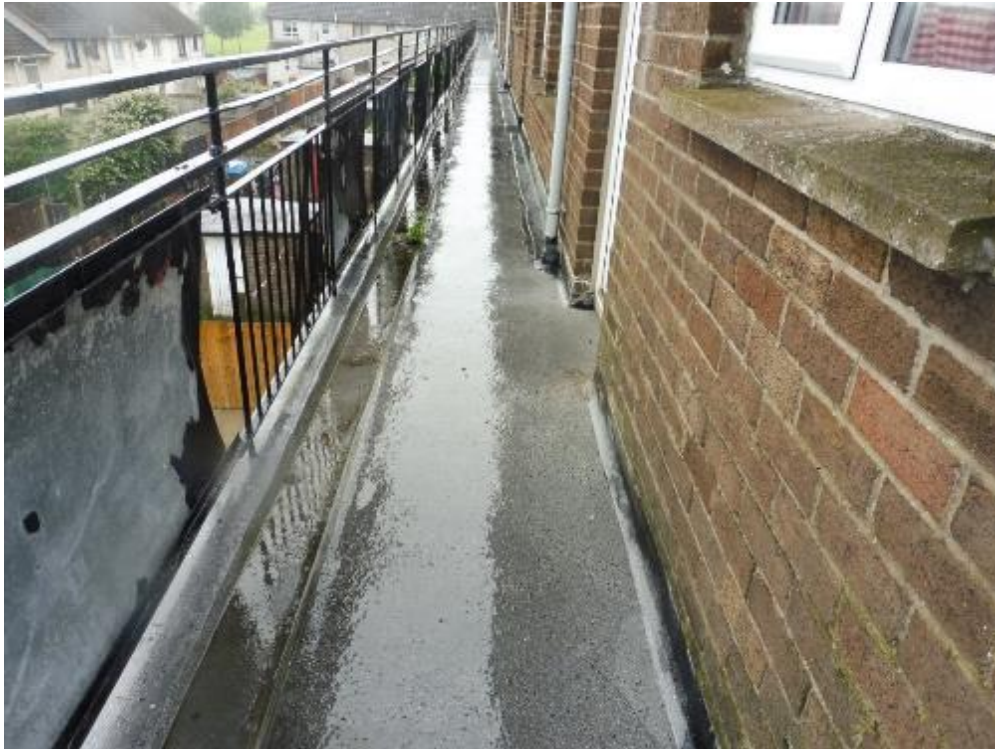
Figure 21 Asphalt to concrete balconies

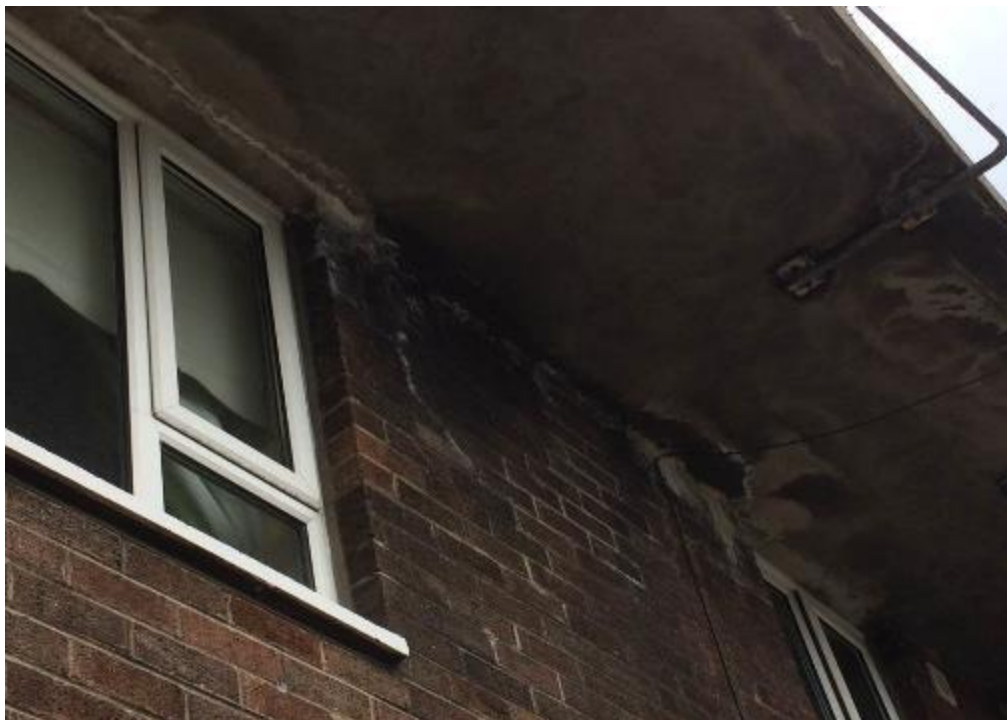
Figure 22 water staining to underside of concrete balcony and external walls of maisonettes

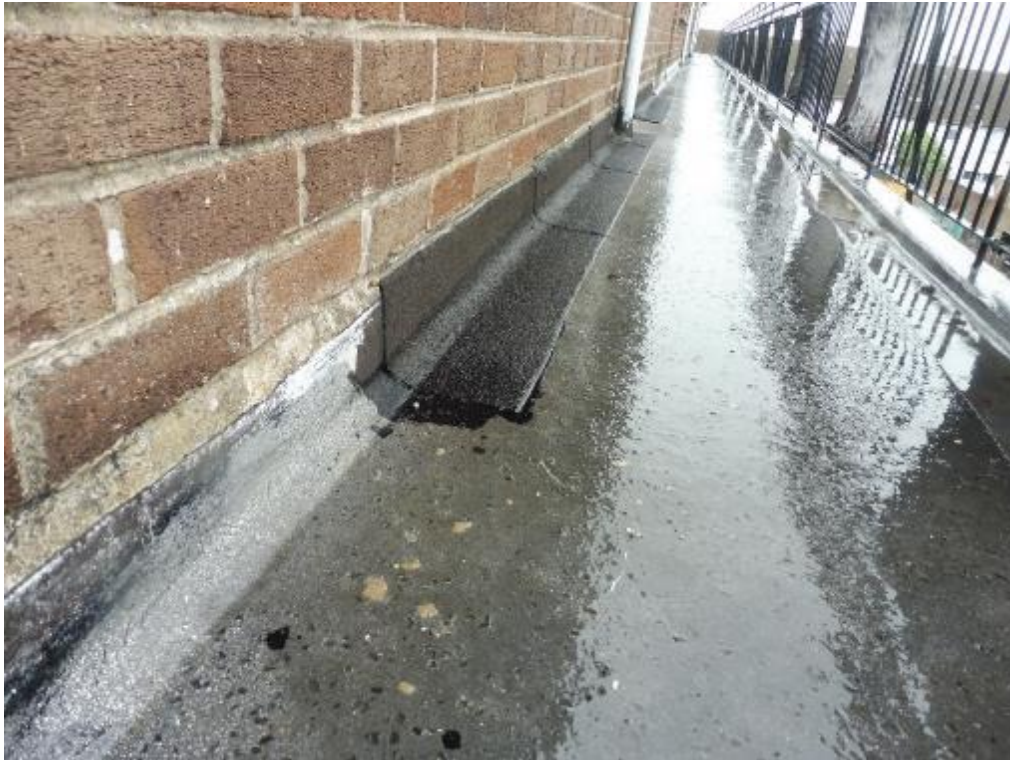
The asphalt skirting detail is incorrect in that the top edge is not dressed into a chase in the wall. There is no asphalt upstand at thresholds of recently installed composite doors to flats – see photograph number 24.

Figure 23 Repairs carried out to where the asphalt meets the external walls at flats

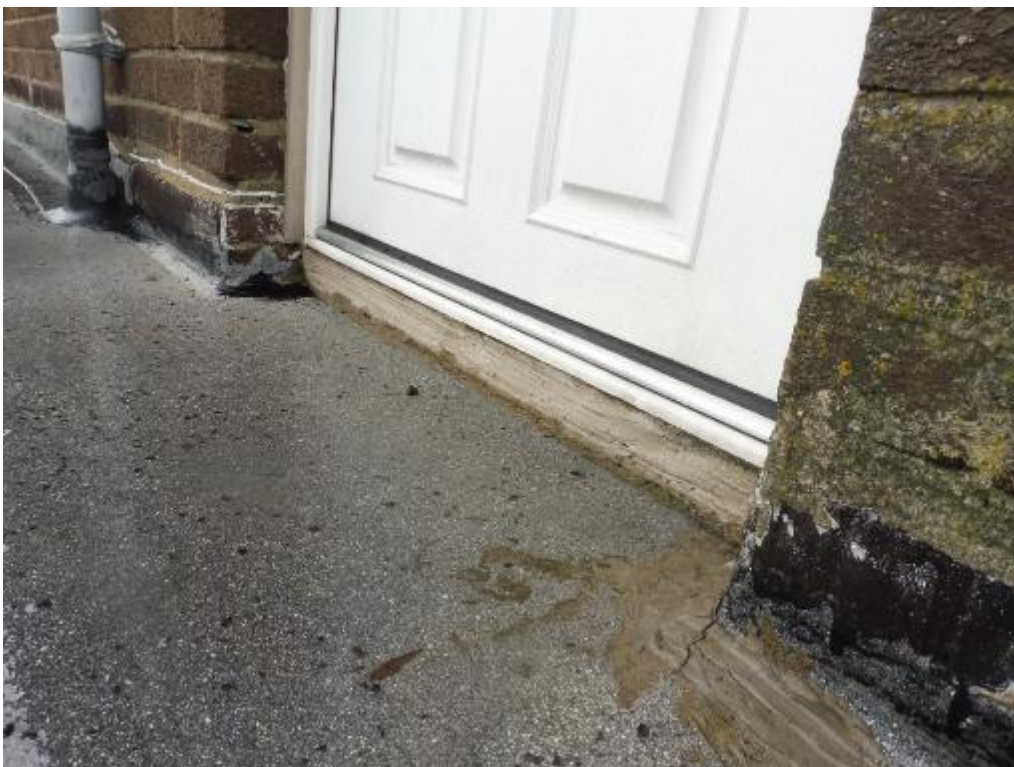
Figure 24 Where new doors have been installed, no asphalt upstand provided

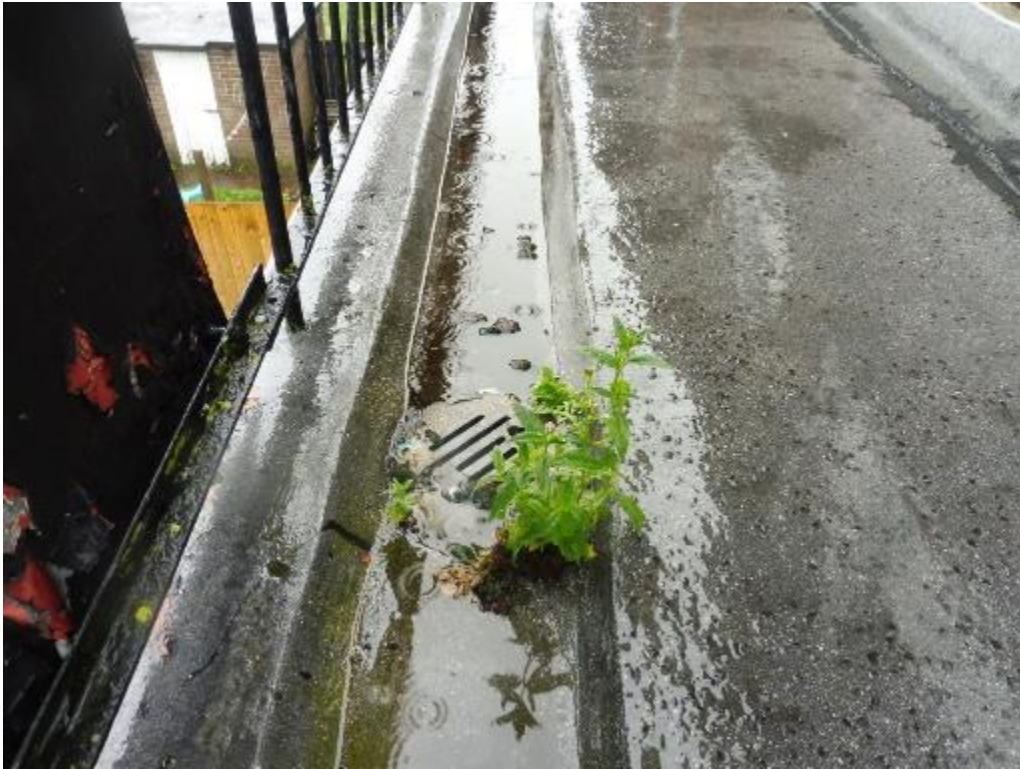
Figure 25 Outlet from the balcony to downpipe below

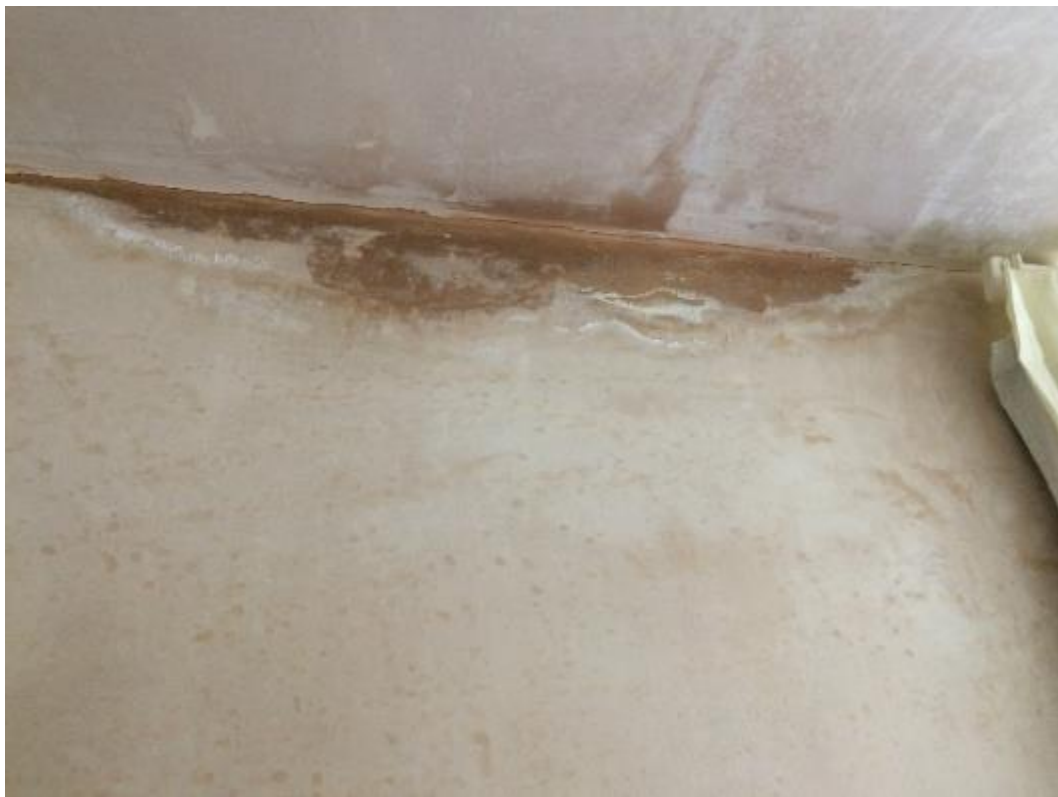
Figure 26 Water staining to rear external wall to bedroom at [REDACTED]

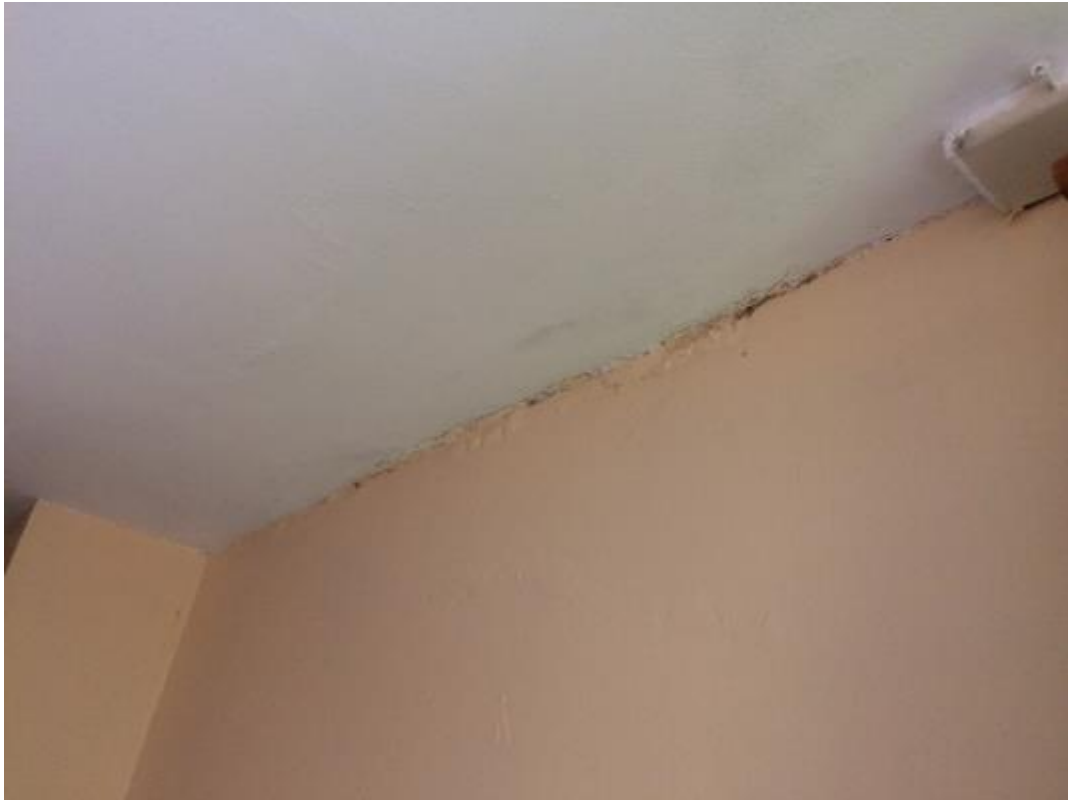
Figure 27 Evidence of water penetration to bedroom at [REDACTED]

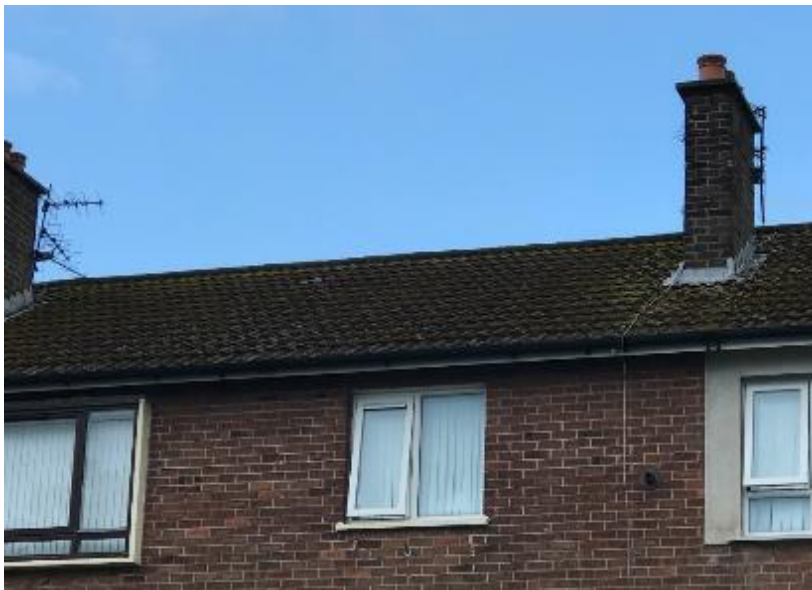
Figure 29 Roofs in need of cleaning

6.05 Clean roof tiles to all blocks and provide biocide spray

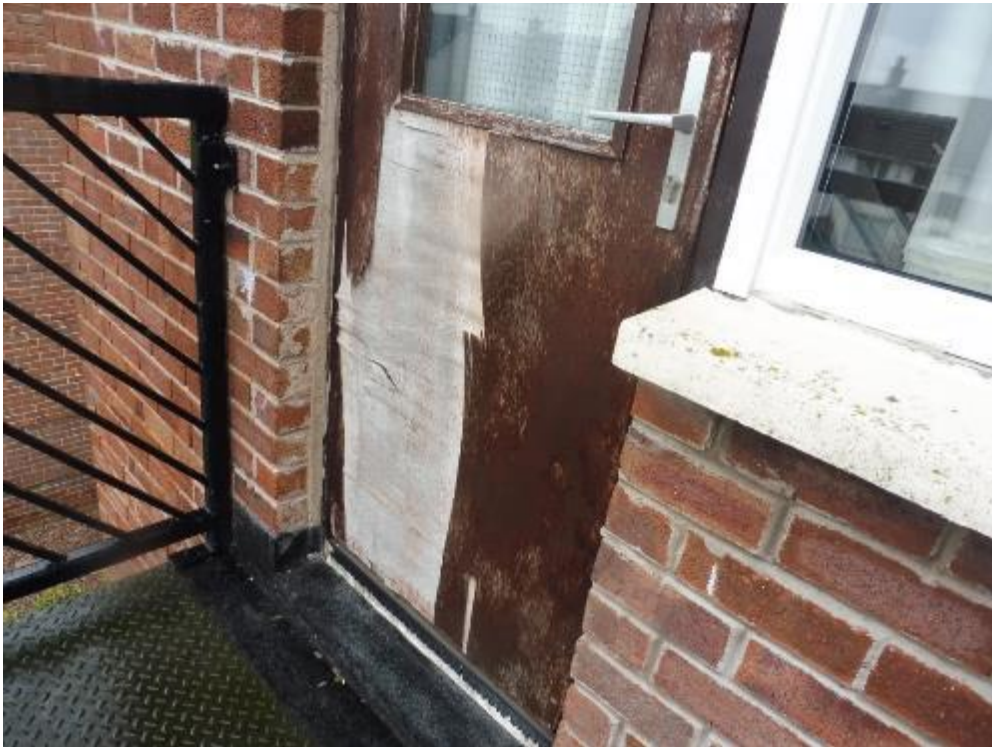
Figure 30 Rear fire exit door in need of replacement

6.07 Replace 3nr defective rear doors with composite door sets at Glassillan Grove and Rossmore Green.
