**Independent
Reference
Group**

Fire Safety in Housing Executive Tower Blocks

Findings Report

JANUARY 2018

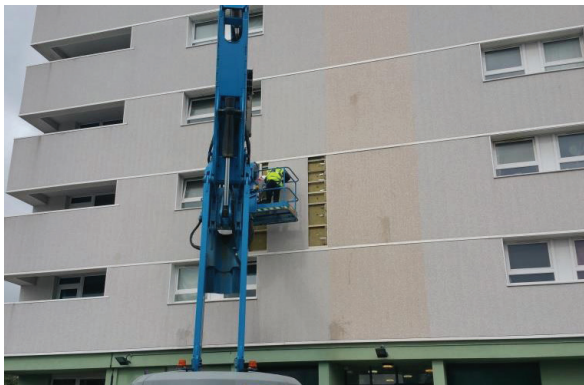
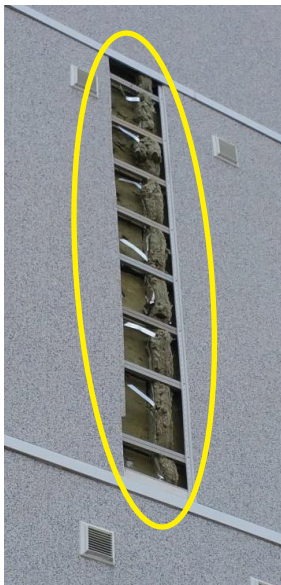
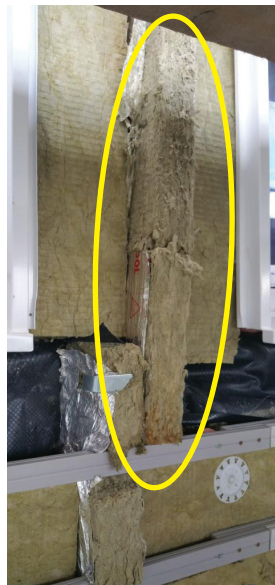
Evidence of 'opening up' and presence of vertical firebreaks in regard to Cúchulainn and Whincroft House tower blocks

- Vertical cavity barriers were present at drying areas;
- The method employed around windows in terms of insulation was considered appropriate by Building Control and NIFRS;
- There was an absence of Rockwool insulation backing to cladding system within drying areas;
- Inlet ventilation arrangements previously existing within drying and refuse chute area and lift lobbies (lobby vents) at each level had been removed - this led to a less than satisfactory situation for smoke ventilation/clearance facilities and an impact on fire-fighting operations;
- Domestic detection within the flat met minimum standards, but in this case not operational in one flat;
- A number of breaches of structure compartmentation within the vertical services riser shaft (internal to flat).
