Cooke & Kettyle Ltd survey – Rosebrook Grove

**AREA CLEARANCE REPORT
FOR
SPECIAL REVENUE WORKS AT
SUNNYLANDS, CARRICKFERGUS
PROJECT NO. 22 / 78 / 1001
FOR
NIHE NORTH REGION**

**COOKE & KETTYLE LLP
CHARTERED SURVEYORS
147 CREGAGH ROAD
BELFAST BT6 0LB
28 OCTOBER 2019**

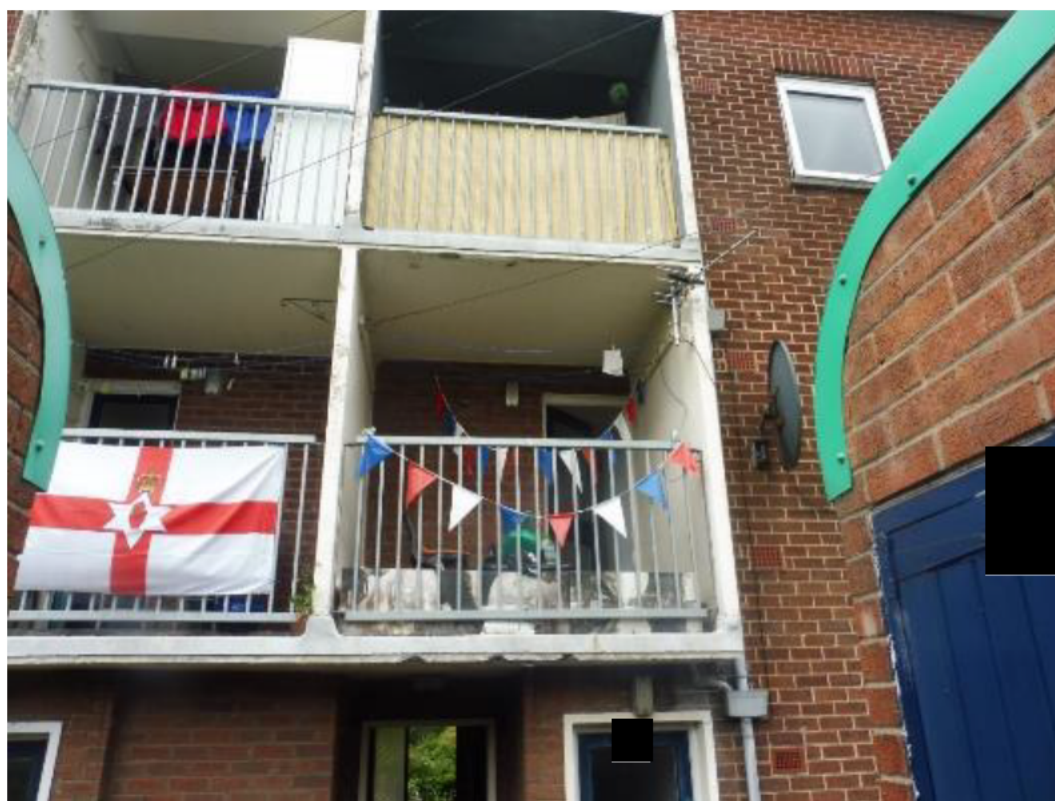
Dwellings in Rosebrook Grove 1- 42 have recessed open drying areas to the rear elevation to first and second floors (see photographs 18 and 19). The floors to these areas are covered with asphalt and are generally approximately 200mm below the floor levels of the flats. The asphalt to these areas is cracked in places and with broken skirtings or with skirtings damaged with saw cuts from previous works. The asphalt skirting detail is incorrect in that the top edge is dressed to the wall rather than being turned into a chase cut into the wall. This is a possible source of water penetration to the dwellings below.

Drainage to these areas is inadequate with 50mm holes through walls from one drying area to another and a 32mm copper pipe outlet leading to a hopper head which is draining into a 100mm uPVC downpipe. The holes through the walls and the copper pipes are currently blocked. Falls in the asphalt are insufficient to remove rainwater in an efficient manner. A few of the drying areas have had flagging installed by the tenant or owner therefore any remedial work may be problematic.

1 Drying areas to Rosebrook Grove

The existing asphalt surfacing will be recoated with a separating layer and 20mm asphalt. The skirtings to these areas will be re-asphalted and a glass reinforced plastic cover flashing will be fitted to the wall (see typical flashing detail at Drawing 003). The holes to the walls between the drying areas will be increased to 100mm and the outlet hole will have a Harmer type mini-balcony outlet (see Drawing 006 Internal Rainwater Outlet) with a 50mm vertical outlet which will be connected to the existing hopper through a 63mm downpipe. Defective asphalt drips (see photograph 19 above) will be reformed with an undercut drip as Drawing 005.

The top surface of the drying areas, which projects 450mm from the external wall, will be treated with two coats of water resistant bituminous black paint.

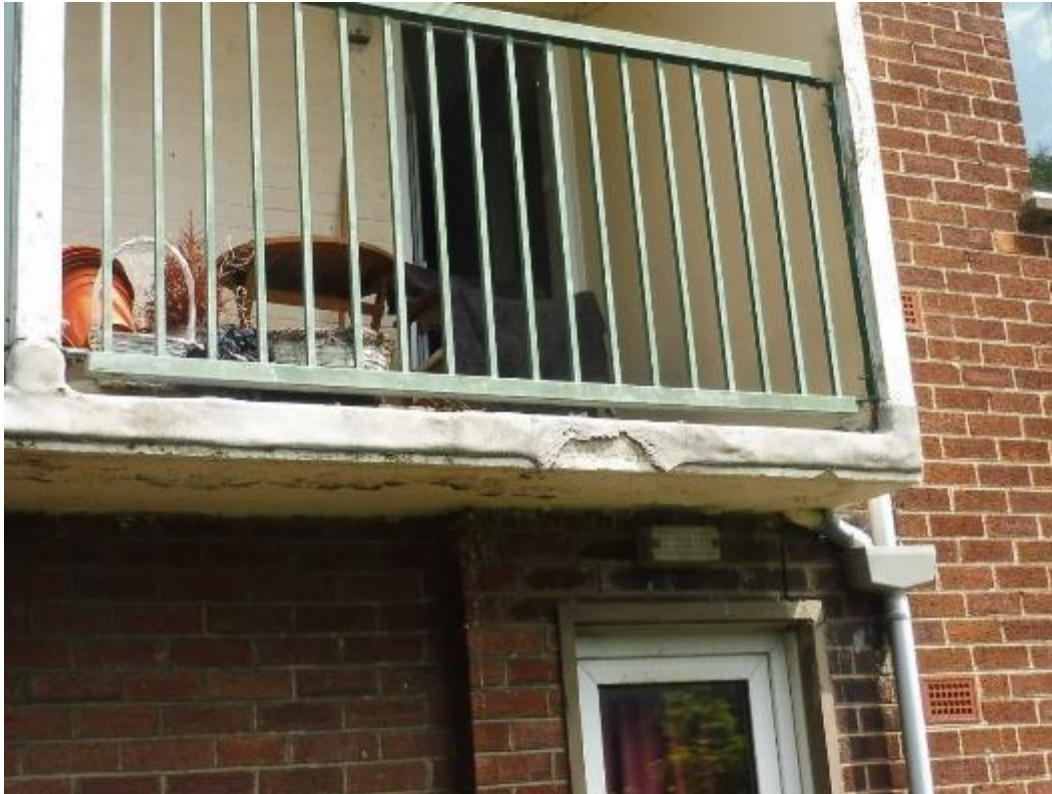
2 Damaged asphalt drip Rosebrook Grove

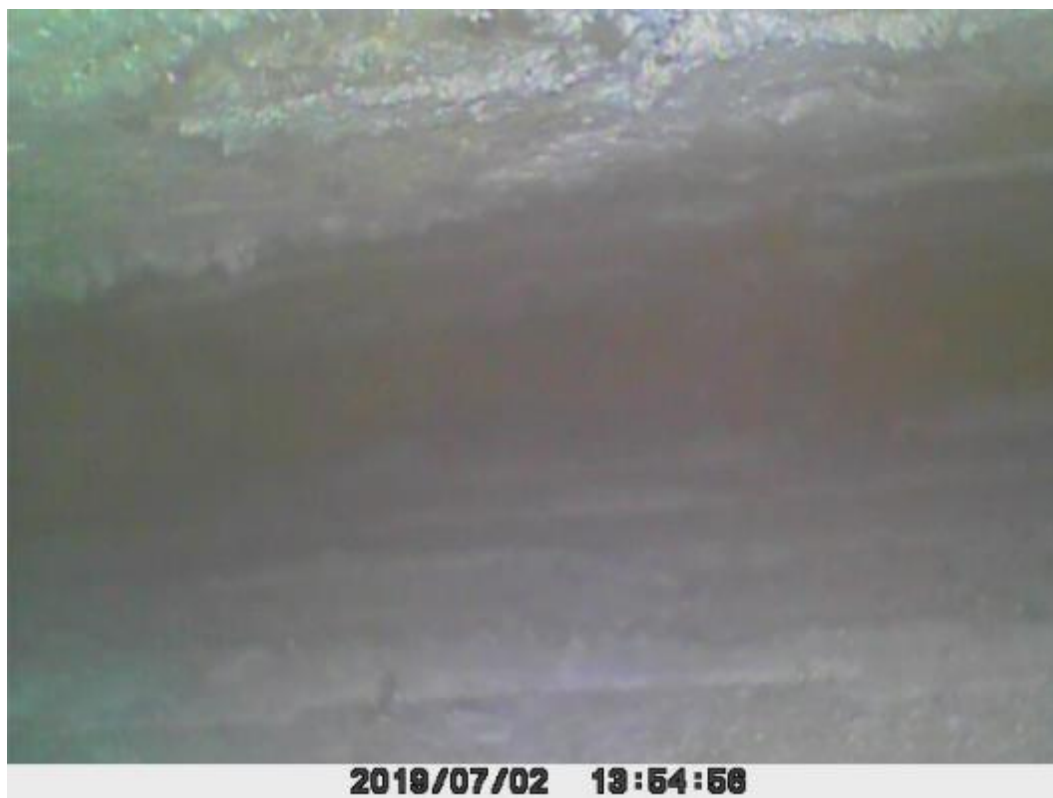
Walls to all blocks have been drilled at various levels to allow checking of the existing cavity insulation with a borescope. The findings are that, at the drill points, there was evidence of blown fibre insulation present within the cavities. In certain instances, significant voids were found in the insulation. Refer to typical photographs 20 to 23 which were taken within the wall cavity. This was the case at both high and low level in the wall elevations. Insulation appears to have settled at upper levels and borescope inspections indicate areas of the cavities that have no insulation present. For example, the extensive mould from condensation at low level internally in Bridewell Drive (photograph 22) appears to be a result of the absence of cavity wall insulation (among other factors).

3 [REDACTED] - insulation absent

The remnants of the existing blown fibre insulation will be mechanically removed by a BBA accredited cavity clean specialist. Cavities will be allowed time to dry and refilled with an approved expanded polystyrene bonded bead cavity wall insulation by a registered installer (BBA accredited) and a Cavity Insulation Guarantee Agency (CIGA) guarantee obtained.

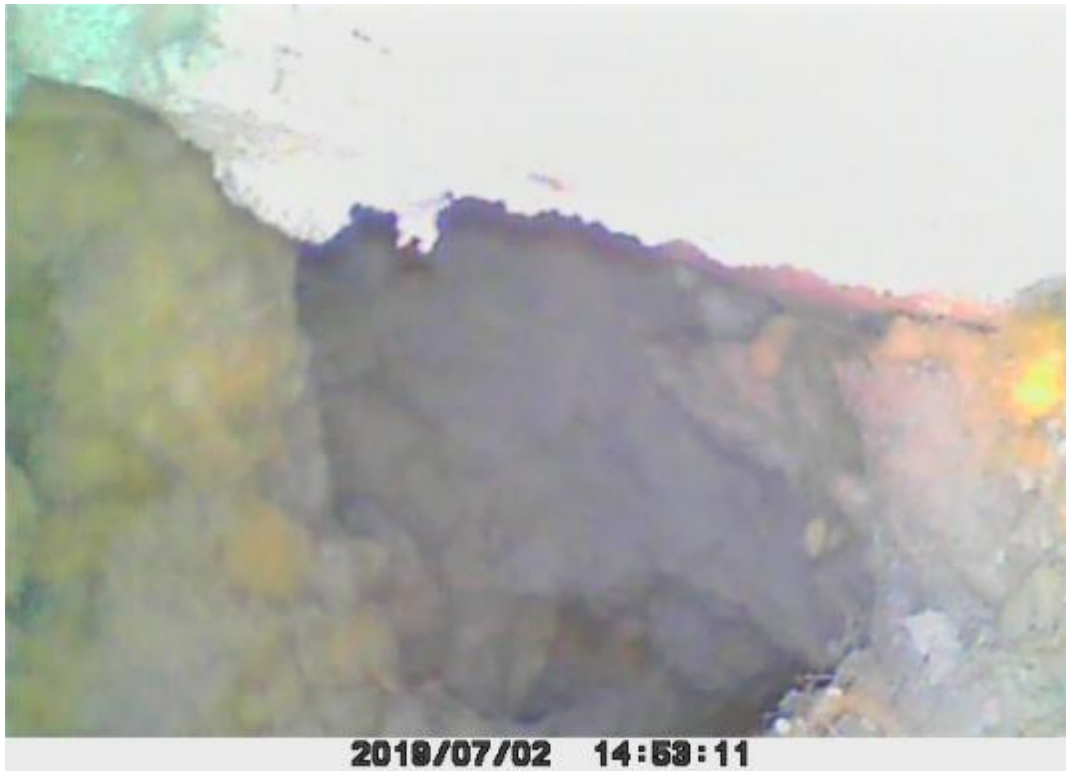
4 Sunnylands Grove - void in insulation

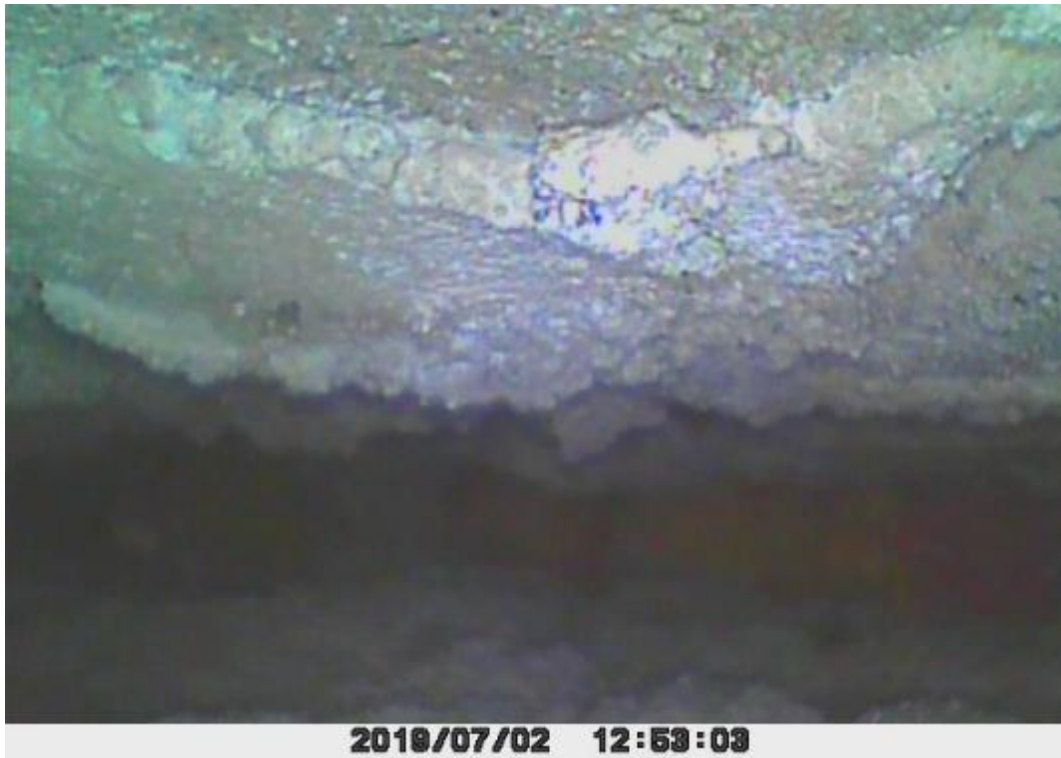
6 *Rosebrook Grove - void in insulation*

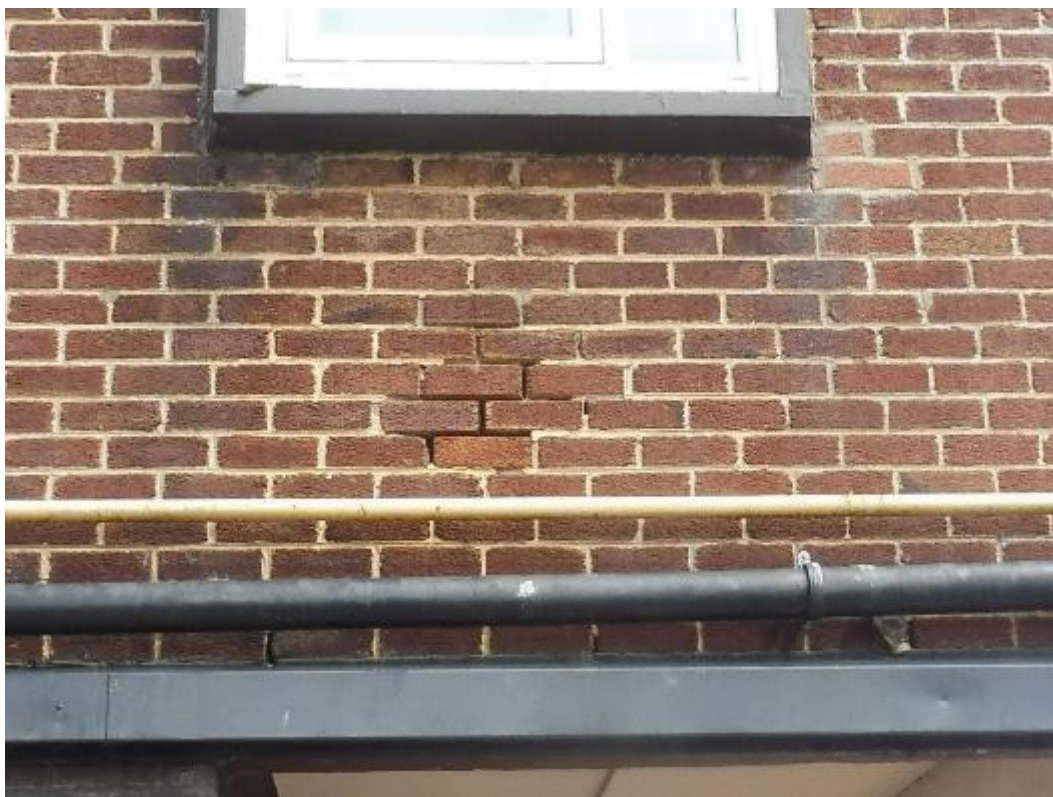
It could also be the case that insulation may not have been installed correctly or that it was installed in the 1980's when industry standards were not as advanced as they are today. The mortar pointing to the existing brickwork is badly weathered, particularly around Bridewell Drive shops and flats, with areas of previously repaired pointing debonding (see photograph 25) and the softer more porous jointing bed being exposed.

7 *Missing mortar to brickwork*

Brickwork and/or render, where covered in moss or water stained, will be cleaned to remove moss and staining (280m²) and treated with a biocide. Where needed, brickwork will be repointed (4994m²) in accordance with the NIHE Specification. A masonry water repellent will be applied (4994m²)

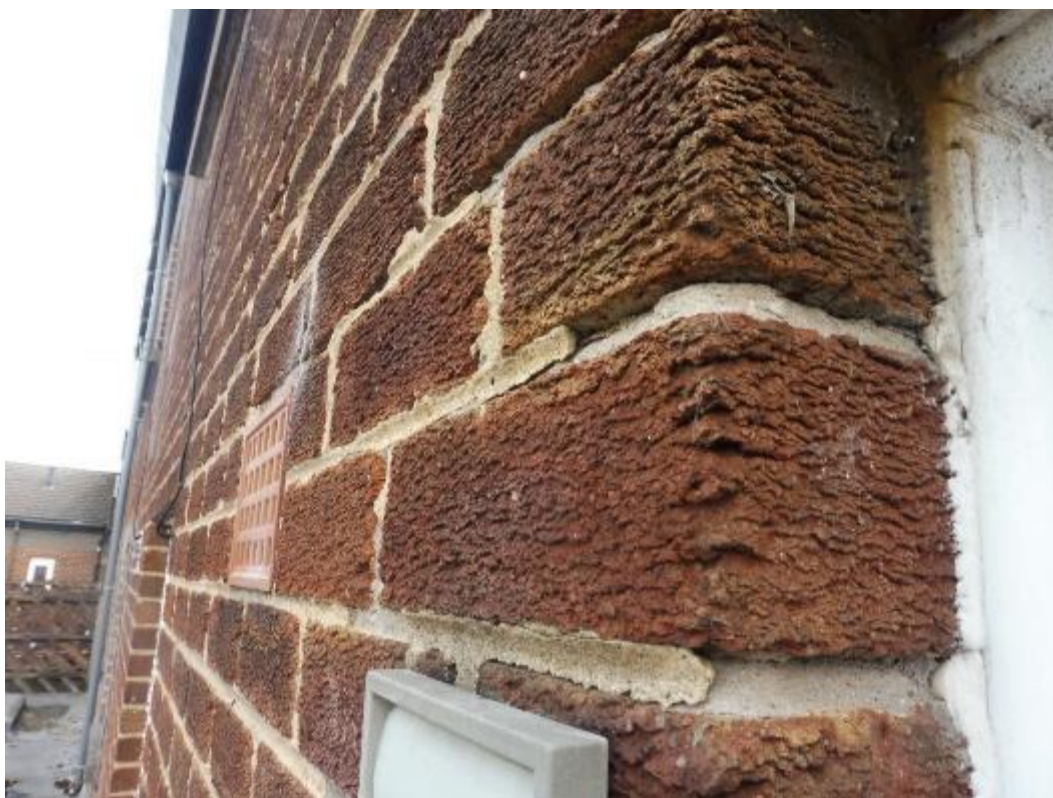
8 Previous repointing now debonding

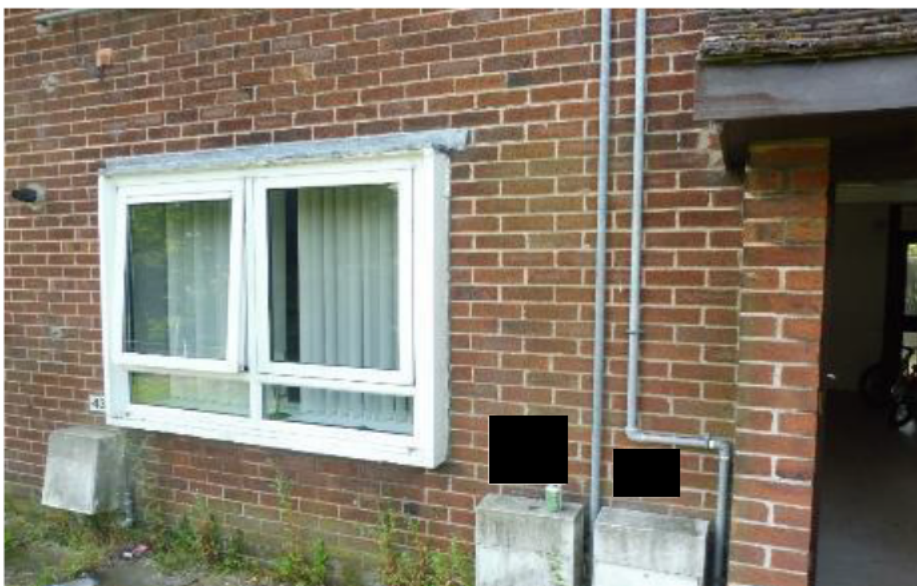
Living room windows to flats generally have precast concrete surrounds which project forward from the external face of the wall. Most flats have recently installed uPVC windows. The precast concrete creates a cold bridge to the internal reveal of the living room. The uPVC windows have been positioned towards the outer edge of the concrete surround, which works to increase the action of the cold bridge. This tends to promote the formation of condensation on the reveal.

Rainwater running down the external face of the wall will run onto the top of the concrete window surround which creates a problem of water ingress as water can bridge the cavity at this point. This is causing plaster staining and debonding to window heads. Most of the surrounds have a lead flashing fitted to counteract this (see photograph below).

9 Typical window surround

Replace window surrounds to match those previously replaced. Install new lintels and sills, build up the jambs to incorporate new damp proof courses and insulation (128 Nr). It is proposed to renew the uPVC windows to match the existing windows.

Where wall finish is fair faced brickwork a self-finished render band will be provided around the top and sides of the window opening.

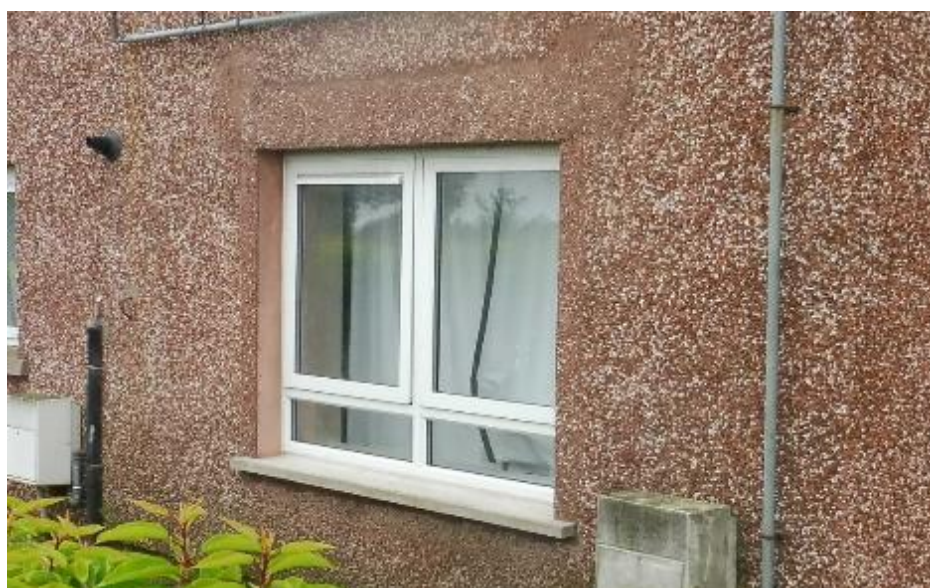
A few dwellings have had these precast concrete surrounds removed already (see photograph 27 below).

10 *Window with concrete surround removed*

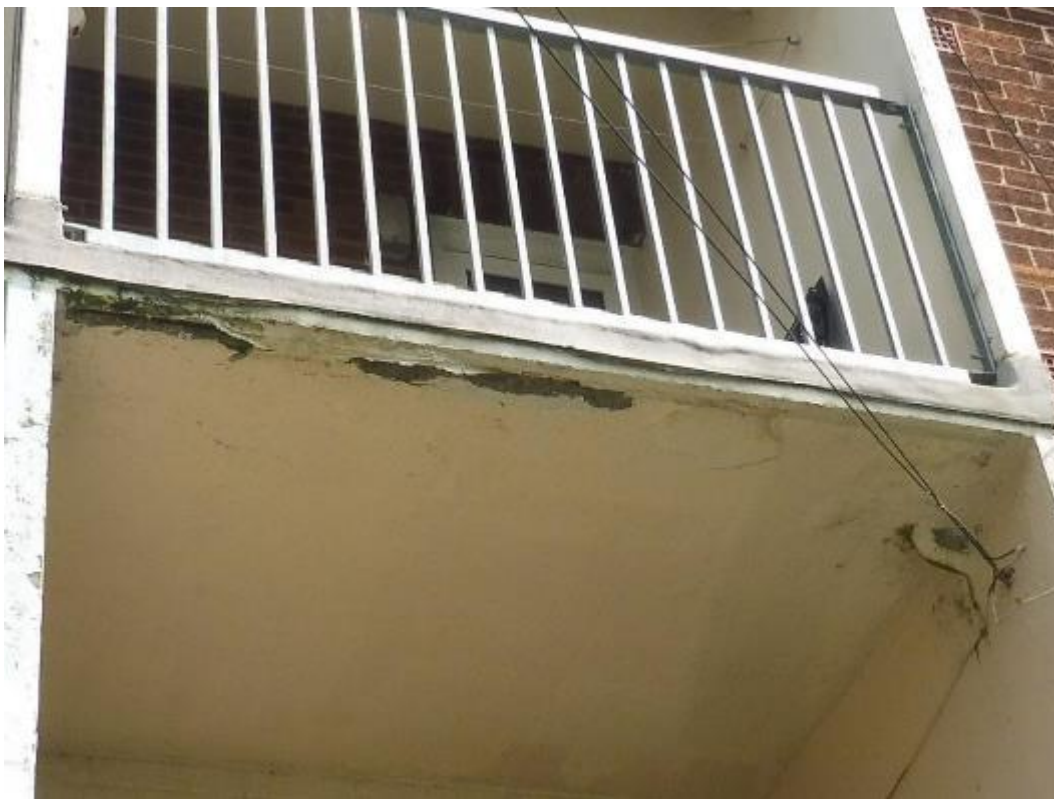
11 Damaged soffit to Rosebrook Grove

6.02 Hack off and replace render to drying area soffit of Sunnylands Grove

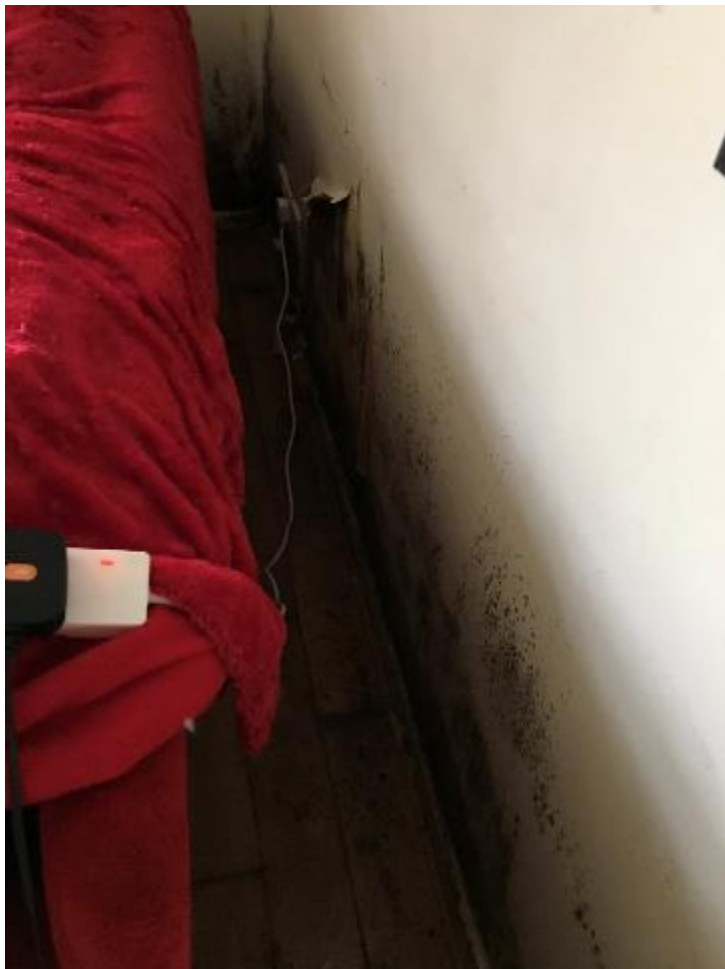
12 *Rosebrook Grove*

7.01 Our surveyors observed a number of scenarios which are contributing to the condensation problems experienced by some tenants, but probably more so by tenants of sold flats. These include:

- a. misuse or lack of knowledge of the correct use of extract fans
- b. the absence of extract fans to bathrooms and/or kitchens in sold flats
- c. the lack of use of window ventilators
- d. the absence of window ventilators in sold flats
- e. inadequate heating and ventilation of flats generally
- f. lack of knowledge of how to minimise the build-up of moisture in flats
- g. general lifestyles
- h. unavoidable cold bridging due to the original building design

To install a positive input ventilation system (PIV) in specific flats or maisonettes (7nr) where condensation issues are a particular problem. These systems are designed to take fresh air from outside, clean the air by means of a filter and discharge the air, via a duct, into the central hallway at high level (filters require to be removed and cleaned every 12 to 24 months). These systems provide a low energy ventilation system.
