Greenisland Carrickfergus Balconies-ECM

SECTION 2
CONDITION REPORT
AND
PROPOSALS

1.00 METAL BALCONIES TO GLASSILLAN GROVE ■ - ■ - ■ - ■

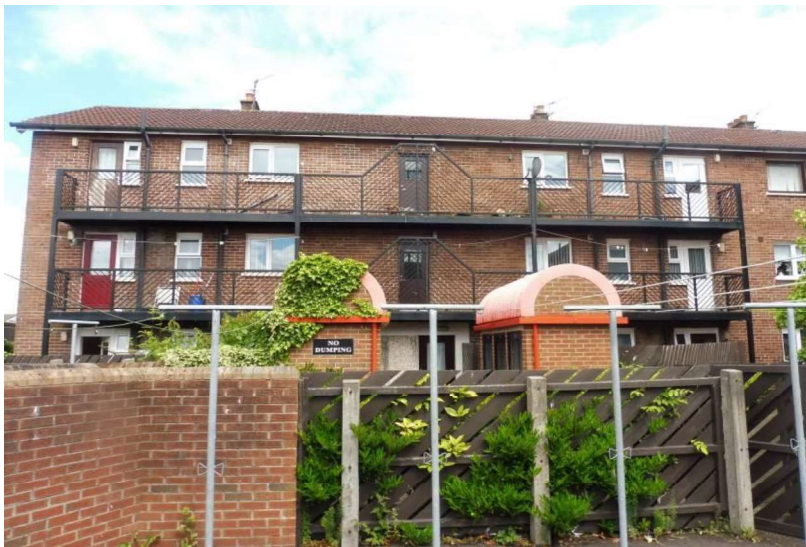
Metal fire escape balconies have previously been added to the blocks of flats at Glassillan Grove at first and second floor level which provide fire escape access to the main stairwells via a rear door in the rear bedroom. The fall to the balconies has either been designed to drain towards the walls of the buildings or there has been an issue with the falls at the time of erecting the balconies. This has given rise to rainwater running off the balconies and soaking the brickwork and, in places, bridging the cavity and staining the wall and/or ceiling plaster in the bedrooms, bathrooms and kitchens at ground and first floor levels.

Figure 1 metal balconies to rear of ■ Glassillan Grove

The existing metal plate flooring to the balconies will be removed and disposed of. A steel packer (to raise the level of the plate) will be bolted to the top of the existing steel channel which is bolted to the external face of the cavity wall. A new metal non-slip raised stud pattern floor plate will be bolted to the steel channels which will have an upturn at the wall. The upturn at the wall will be covered with a polyester powder coated flashing with the top edge dressed into a raked out brickwork joint and the flashing screwed to the wall. The flashing will be sealed at the brickwork joint and where it covers the upturn with a low modulus polyurethane sealant. The outer edge will drain into a new rainwater gutter which will be fixed to the external support channel and drained through downpipes connected to the existing downpipes fixed to the rear wall of the flats or, where this is not feasible, to a new gully trap connected into the existing storm drainage system. Existing handrails which are bolted to the outside channel will be removed and refitted as work proceeds. All steelwork will be redecorated following completion of the works on a block by block basis (see DETAIL 1 on next page). Works associated with this element would require careful planning and programming with the Contractor to minimise disruption for the tenants and owners as well as removing or minimising all areas of risk to the tenants, owners and Contractor's workforce.

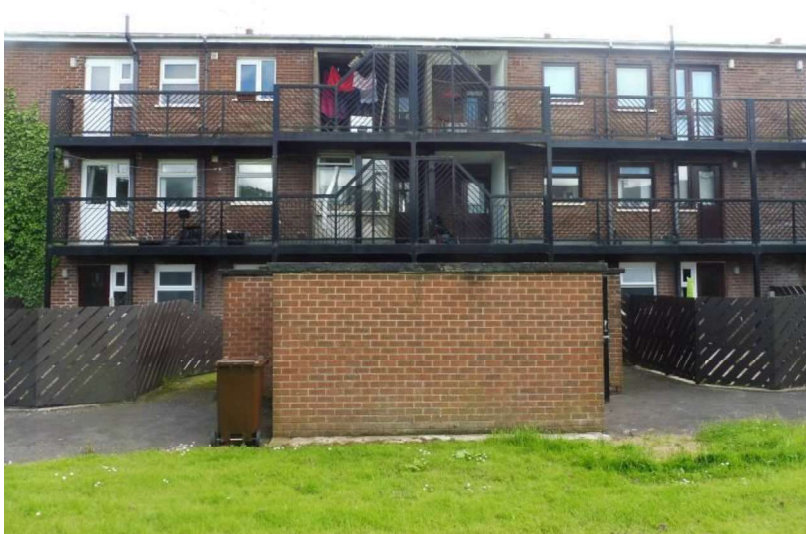
Figure 2 metal balconies to rear of ■ Glassillan Grove with drying areas

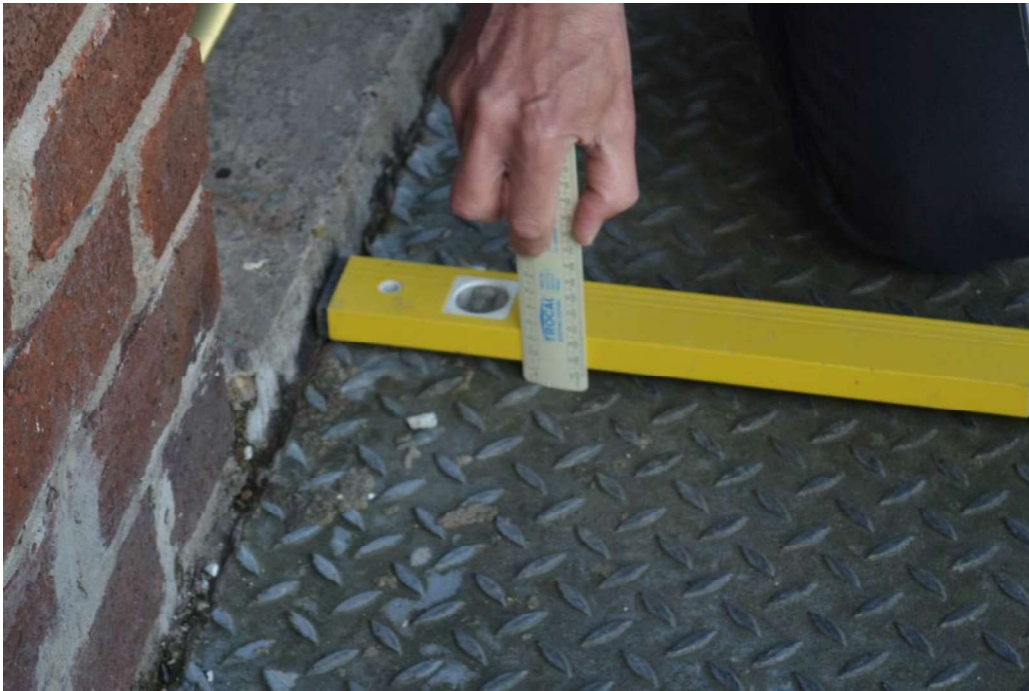
Figure 3 Metal decking laid to incorrect falls into the building

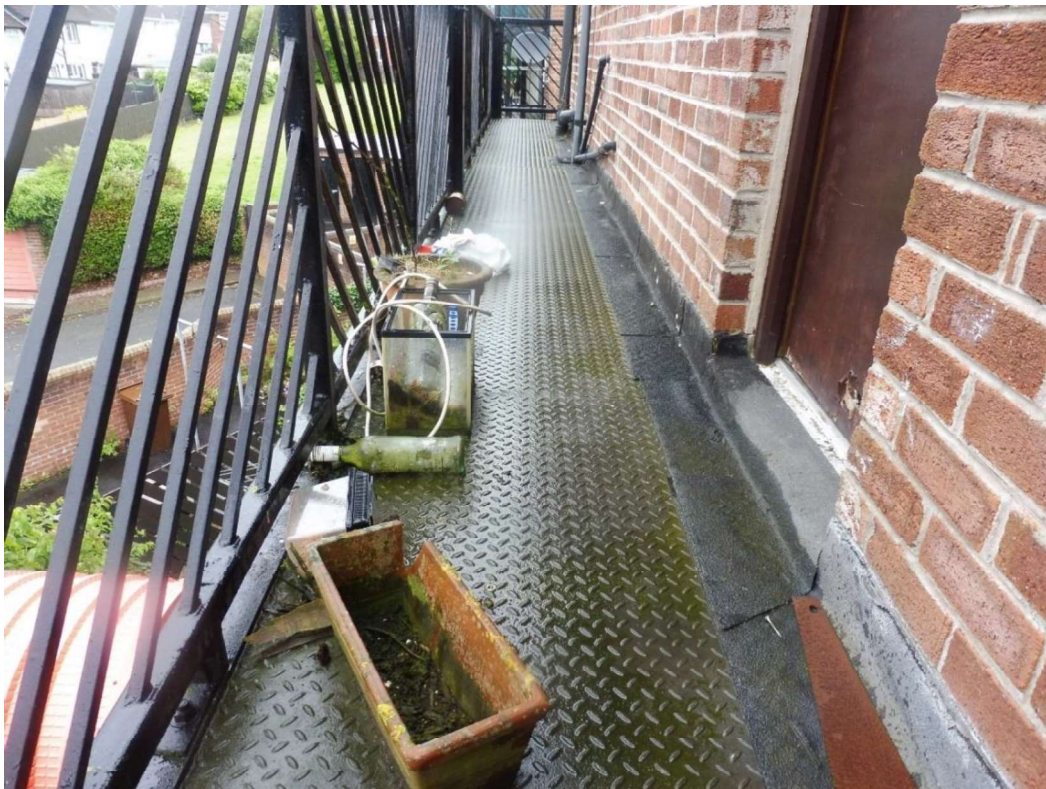
Figure 4 Repairs carried out to existing balconies include temporary felt flashings

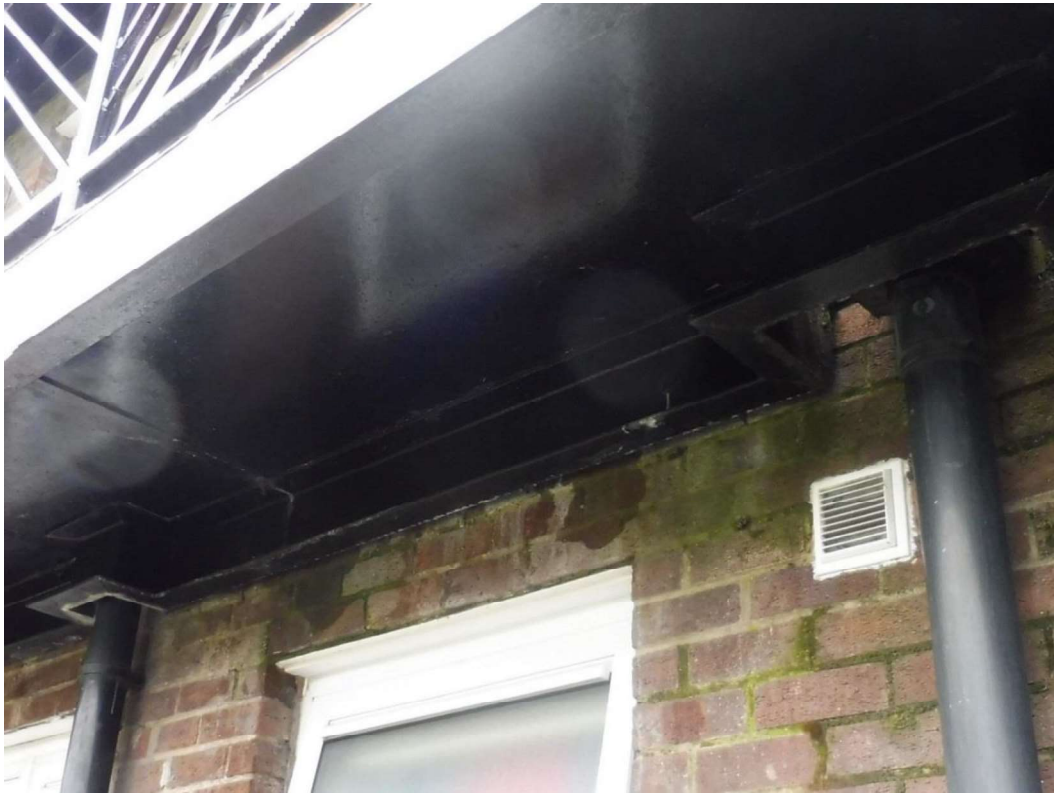
Figure 5 Mould on walls where water runs off balcony and down external walls

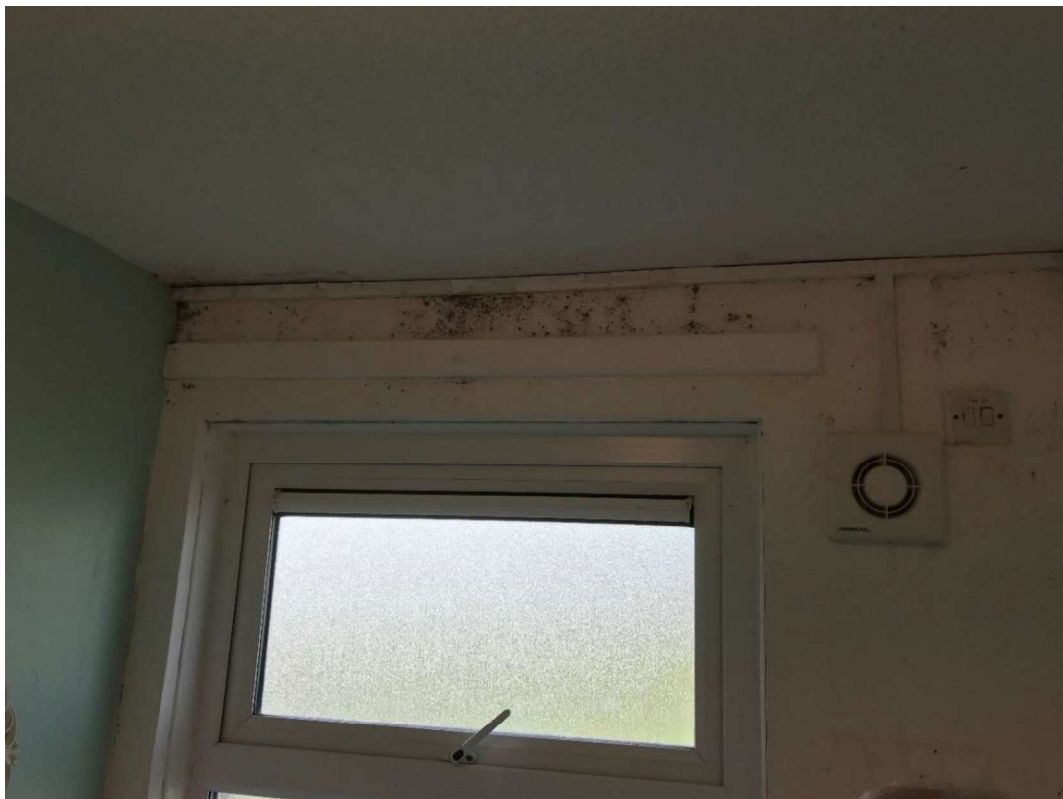
Figure 6 Evidence of water ingress from water coming off balcony to [REDACTED] Glassillan Grove

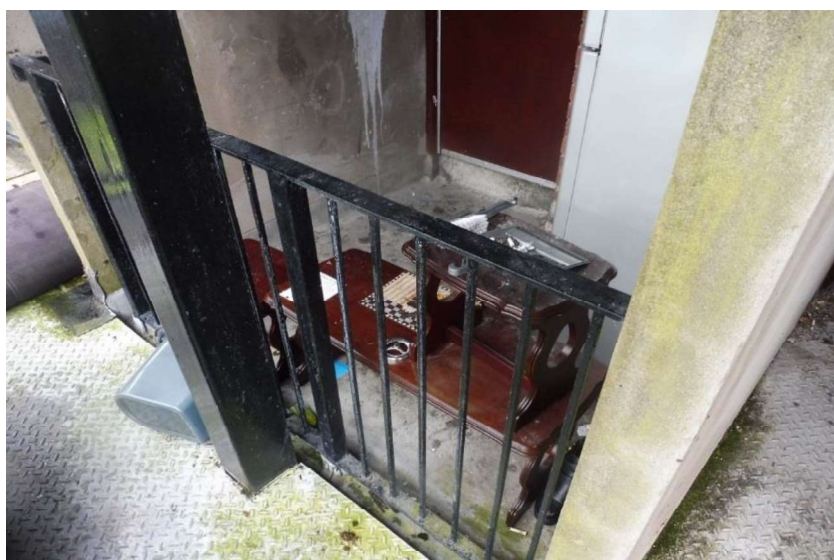
Blocks ■ Glassillan Grove have recessed open drying areas to the rear elevation. The floors to these areas are covered with asphalt and are generally approximately 200mm below the floor levels of the flats and metal balconies. The asphalt to these areas is cracked in places and with broken skirtings or with skirtings damaged with saw cuts from previous works. The asphalt skirting detail is incorrect in that the top edge is dressed to the wall rather than being turned into a chase cut into the wall. This is possibly leading to water penetration to stores below, which in isolated cases, have mould growth to walls and ceilings. This problem is probably exacerbated by a lack of heat or ventilation to these stores.

Figure 7 Asphalt drying areas with metal railing to front and access door from flat

The existing asphalt surfacing will be recoated with a separating layer and 20mm asphalt. The skirtings to these areas will be re-asphalted and a glass reinforced plastic cover flashing will be fitted to the wall (see typical flashing detail at Drawing 003). The holes to the walls between the drying areas will be increased to 100mm and the outlet hole will have a mini-balcony outlet (see Drawing 006 Internal Rainwater Outlet) with a 50mm vertical outlet which will be connected to the existing hopper through a 63mm downpipe.

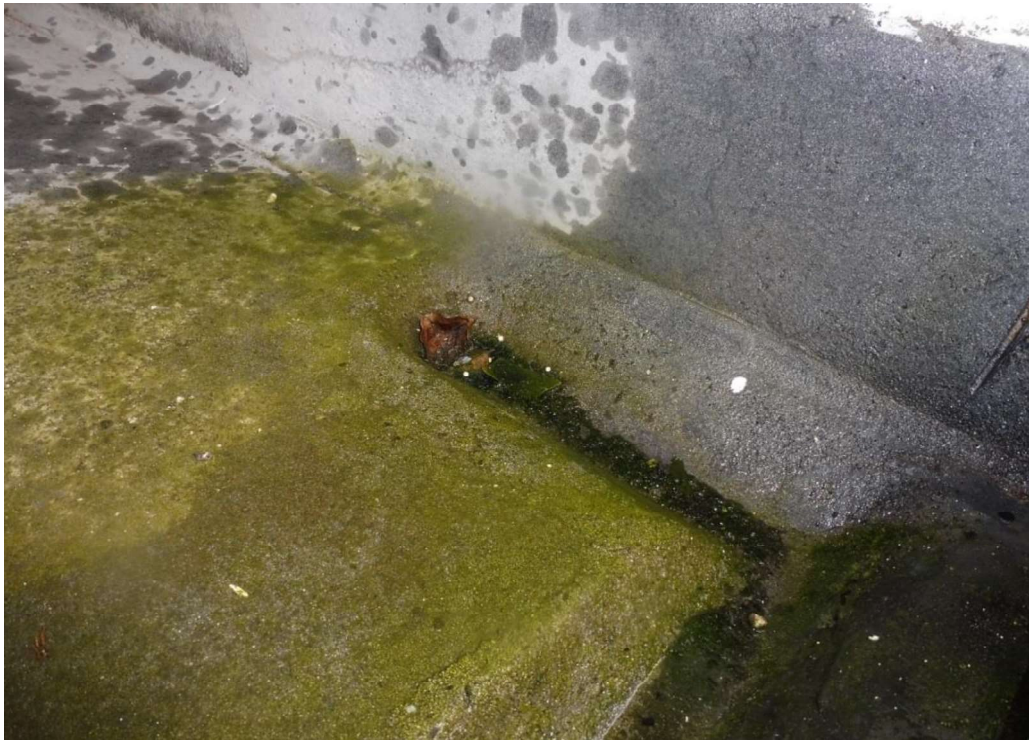
Drainage to these areas is inadequate with 50mm holes through walls from one drying area to another and a 32mm copper pipe outlet leading to a hopper head which is draining into a 100mm uPVC downpipe. The holes through the walls and the copper pipes are currently blocked. Falls in the asphalt are insufficient to remove rainwater in an efficient manner. A few of the drying areas have been enclosed by the tenant or owner therefore any remedial work may be problematic.

Figure 8 Blocked outlet leading to a 32mm copper pipe

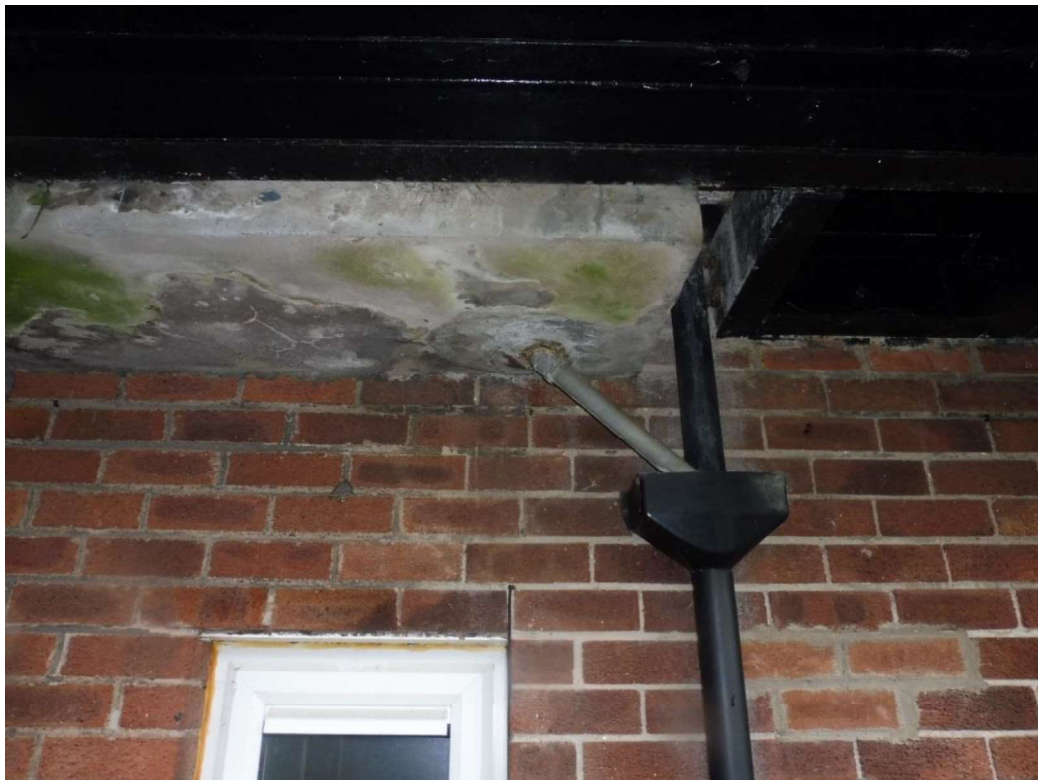
Figure 9 Pipe outlet from drying areas to hopper head

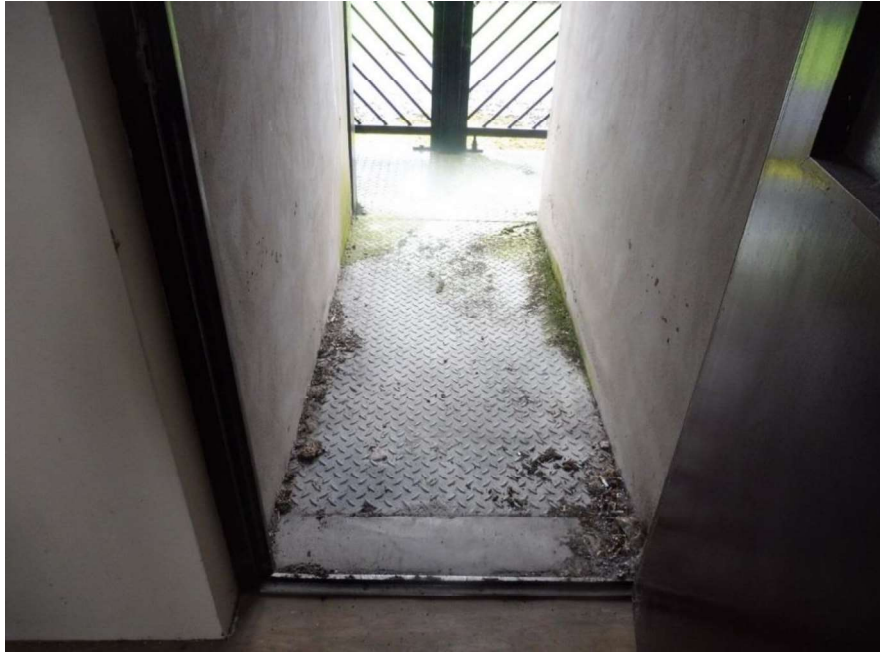
Between the drying areas are the fire escape routes from the balconies to the stairs within the communal halls. These areas are covered with durbar type steel flooring which could not be removed at survey stage for inspection. Any problems which are discovered to these areas during the works will need to be assessed and designed as works progress.

Figure 10 Fire escape route from balcony to communal hall door

The escape route leading up to the fire escape door which is between drying areas has a metal surface at the same level as the balcony surface. We have been unable to lift this to establish the nature of the flooring below but we believe it would be fair to assume that it is the same as the asphalt flooring and skirtings to the drying areas and would need to be recovered and have the proposed drainage works continued to this area.

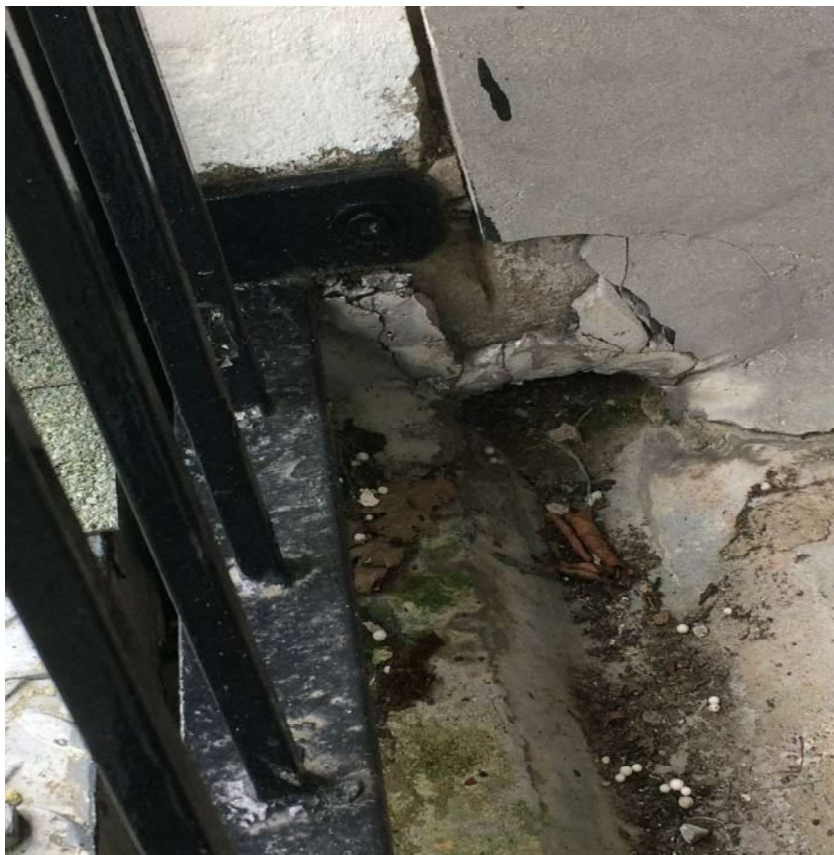
Figure 11 Damage to asphalt possibly leading to water penetration to dwellings below

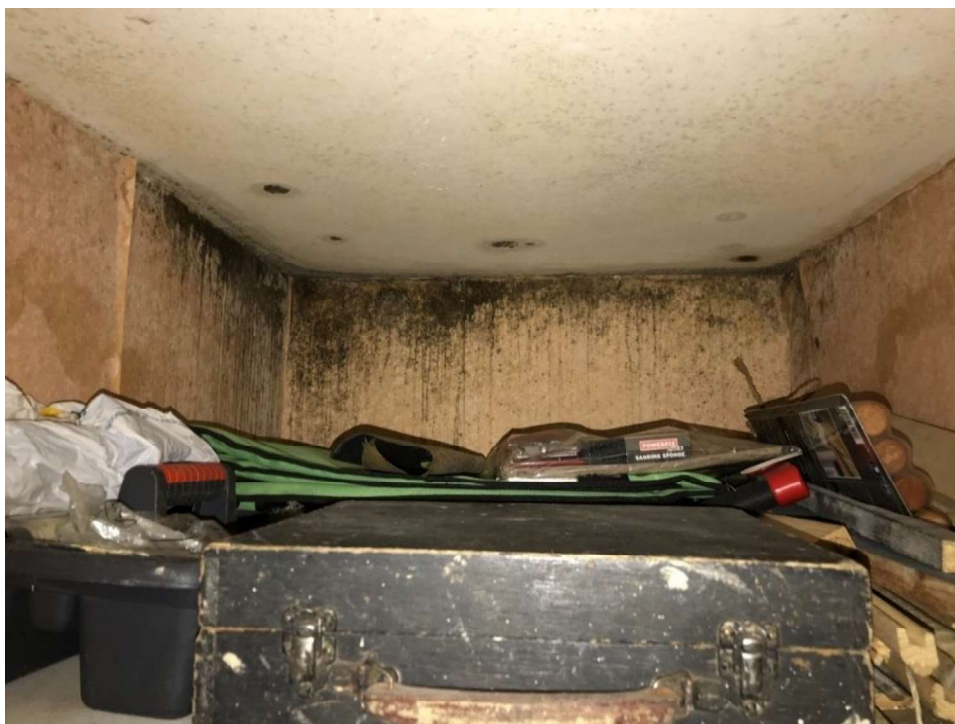
Figure 12 Evidence of water ingress to store below drying area to [REDACTED] Glassillan Grove

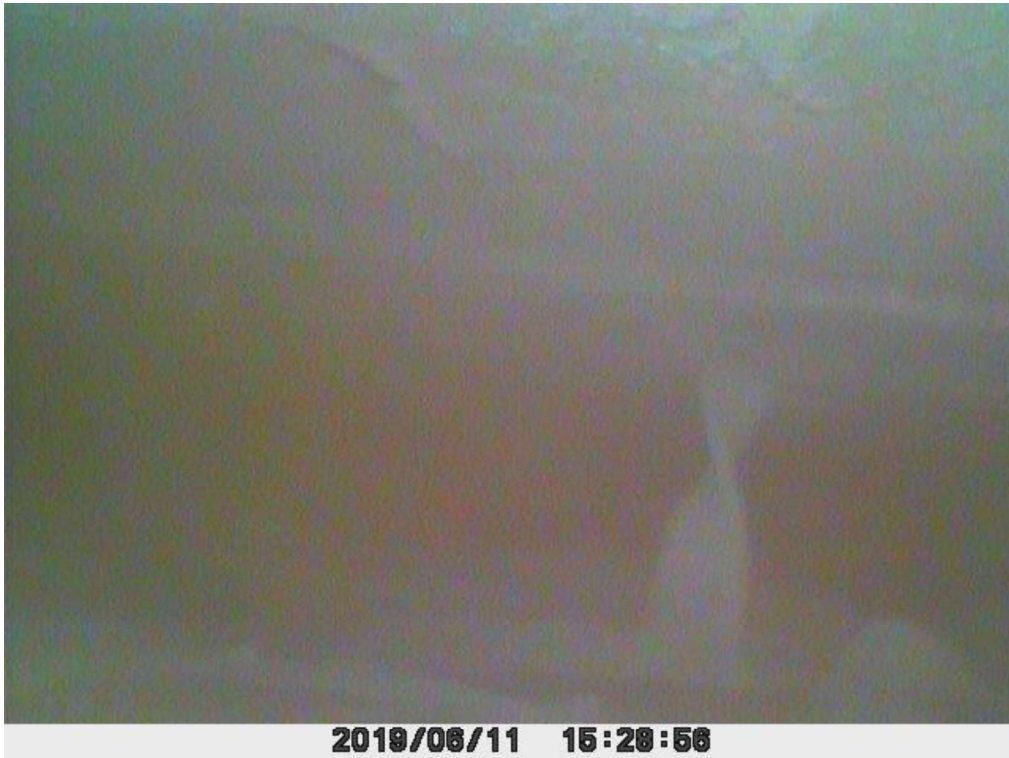
Walls to all blocks have been drilled at various levels to allow checking of the existing cavity insulation with a boroscope. The findings are that, at Rossmore Green, there is a mixture of different types of insulation to the cavities with some white beads having been used and some blown fibre evident, in all other instances the walls have been insulated with white polystyrene beads. In all cases areas of missing cavity insulation were observed. Refer to typical photographs 13 to 15 which were taken within the wall cavity. This was the case at both high and low level in the wall elevations. Insulation has settled and boroscope inspections indicate areas of the cavities that have no insulation present.

Figure 13 Block [REDACTED] - Glassillan Grove – Insulation absent

The remnants of the existing blown fibre or bead cavity insulation will be mechanically removed by a BBA accredited cavity clean specialist. Cavities will be allowed time to dry and refilled with an approved expanded polystyrene bonded bead cavity wall insulation by a registered installer (BBA accredited) and a Cavity Insulation Guarantee Agency (CIGA) guarantee obtained.

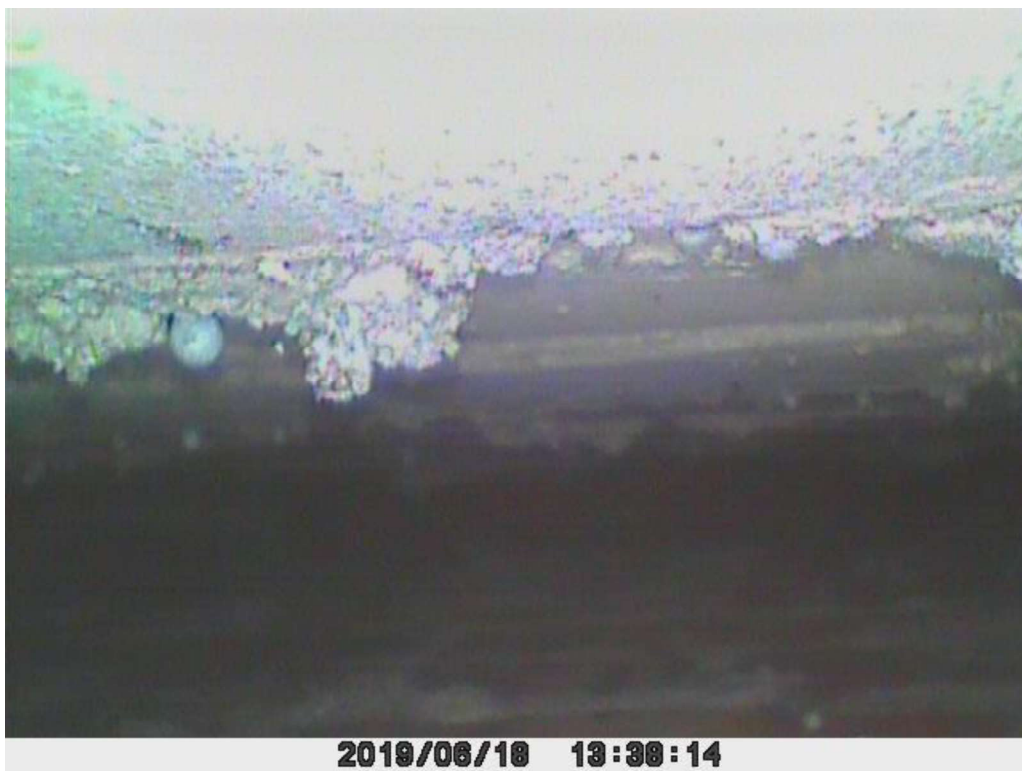
Figure 14 Block [REDACTED] – Glassillan Grove – Insulation absent

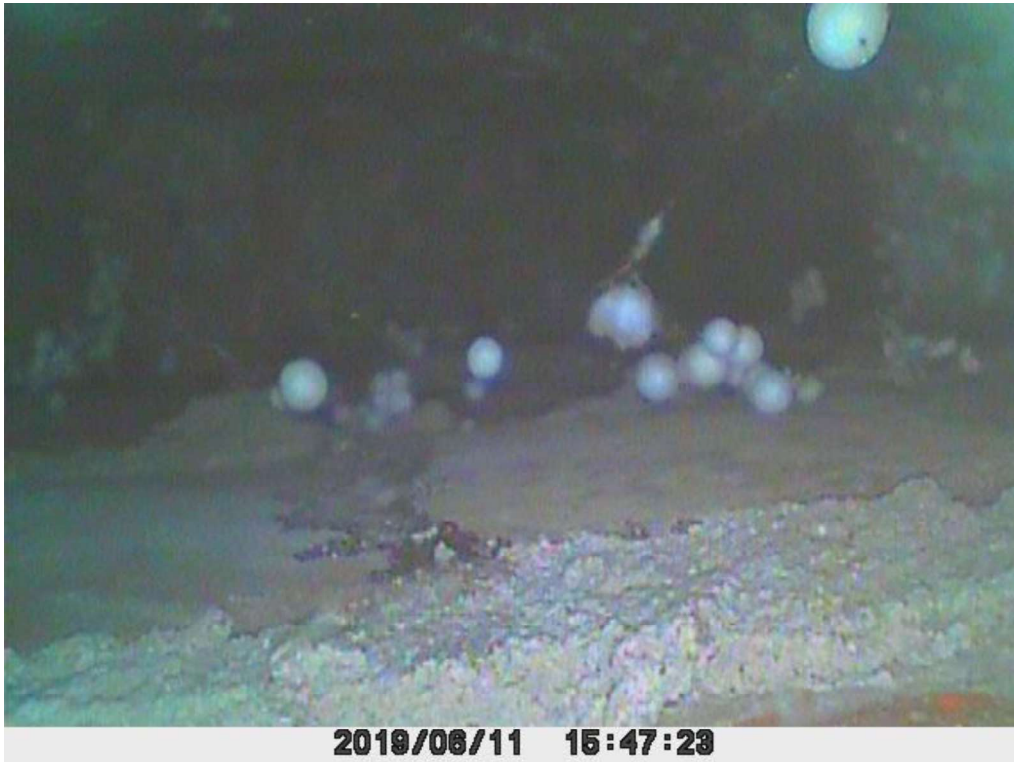
Figure 15 Rossmore Green - Void in insulation

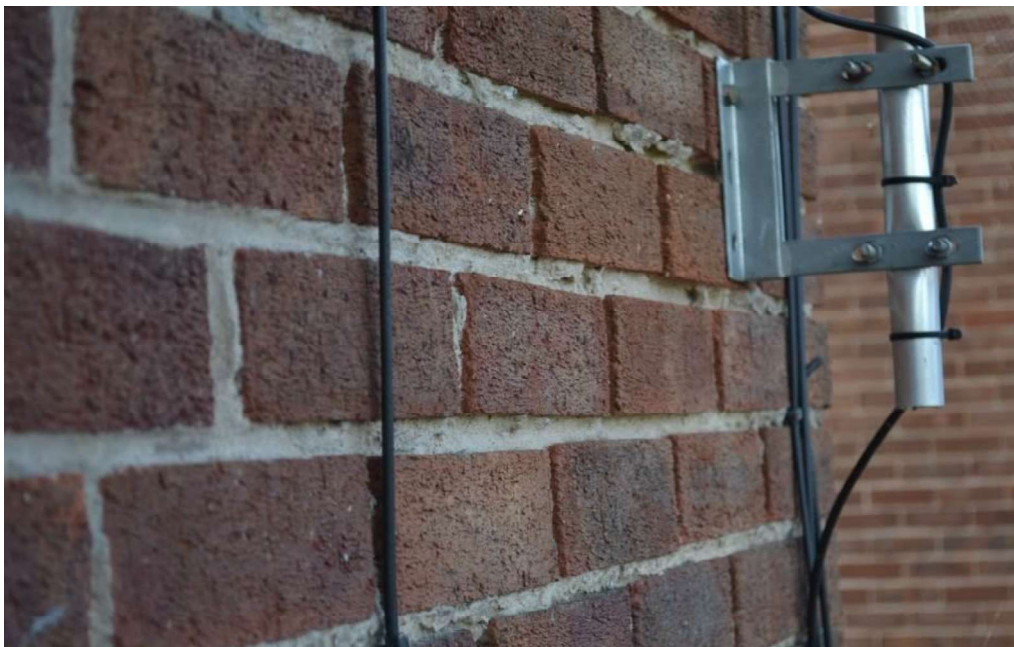
It could also be the case that insulation may not have been installed correctly or that it could have been installed in the 1980's when industry standards were not as advanced as they are today. The mortar pointing to the existing brickwork is badly weathered with areas of pointing having lost its struck joint and the softer more porous jointing bed being exposed. A mortar fillet has been provided at reveals of windows and external doors.

Figure 16 Poor mortar pointing to the existing brickwork

Brickwork, where covered in moss or water stained, will be cleaned to remove moss and staining (260m²) and treated with a biocide. All brickwork will be repointed (3980m²) in accordance with the NIHE Specification. A masonry water repellent will be applied (3980m²). Mortar fillets will be provided to all window and door reveals.

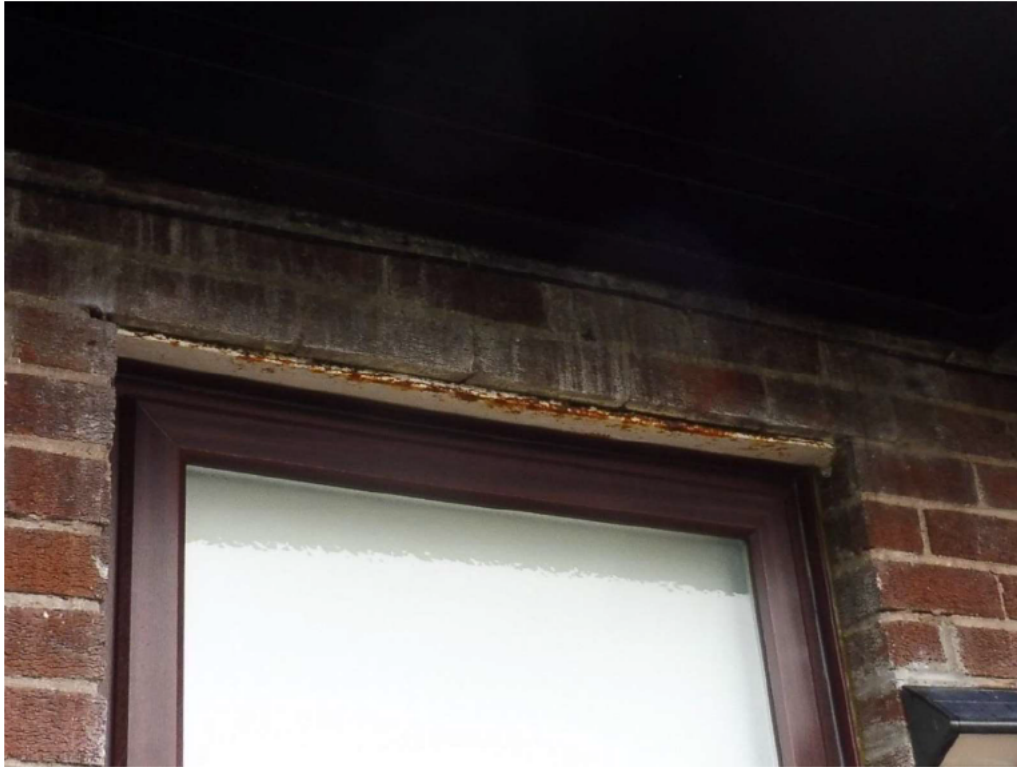
Steel angle lintels over windows and doors have rusted in numerous positions due to the water ingress as described in section 1.01 above. These lintels are now affected by ferrous oxide which is causing the steel to expand and widen the joints within the surrounding brickwork.

Figure 17 Steel angle irons affected by rust

Steel lintels will be replaced where affected by rusting. This will entail cutting out the existing steel lintel together with the end brickwork and the brickwork courses carried by the lintel. It is proposed to use a stainless steel lintel together with a rigid plastic cavity type cavity damp proof course with end closers and weep holes fitted above the lintel, the brickwork above the lintels will be built up using the salvaged existing bricks to maintain the existing appearance as far as possible. (118Nr)

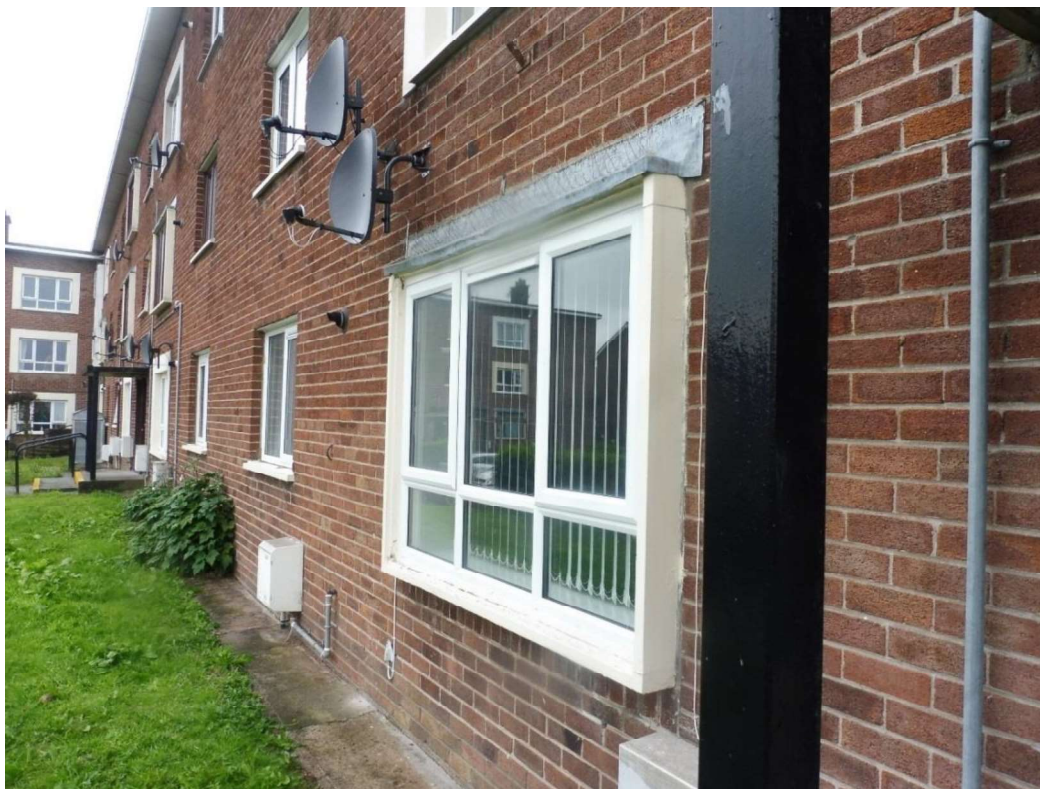
Living room windows to flats generally have precast concrete surrounds which project forward from the external face of the wall. Most flats have recently installed uPVC windows. The precast concrete creates a cold bridge to the internal reveal of the living room. The uPVC windows have been positioned towards the outer edge of the concrete surround, which works to increase the action of the cold bridge. This tends to promote the formation of condensation on the reveal.

Rainwater running down the external face of the wall will run onto the top of the concrete window surround which creates a problem of water ingress as water can bridge the cavity at this point. This is causing plaster staining and debonding to window heads. Most of the surrounds have a lead flashing fitted to counteract this (see photograph below).

Figure 18 A typical concrete window surround

It is proposed to replace the (11 Nr) window surrounds to match those previously replaced. The window surrounds will be removed and new precast concrete lintels and sills will be built in, jambs will be built up and a new damp proof course and insulation will be provided to lintels, sills and jambs. A self-finished render band will be provided around the top and sides of the window opening. Internal wall plaster will be made good and a new PVC window will be installed.

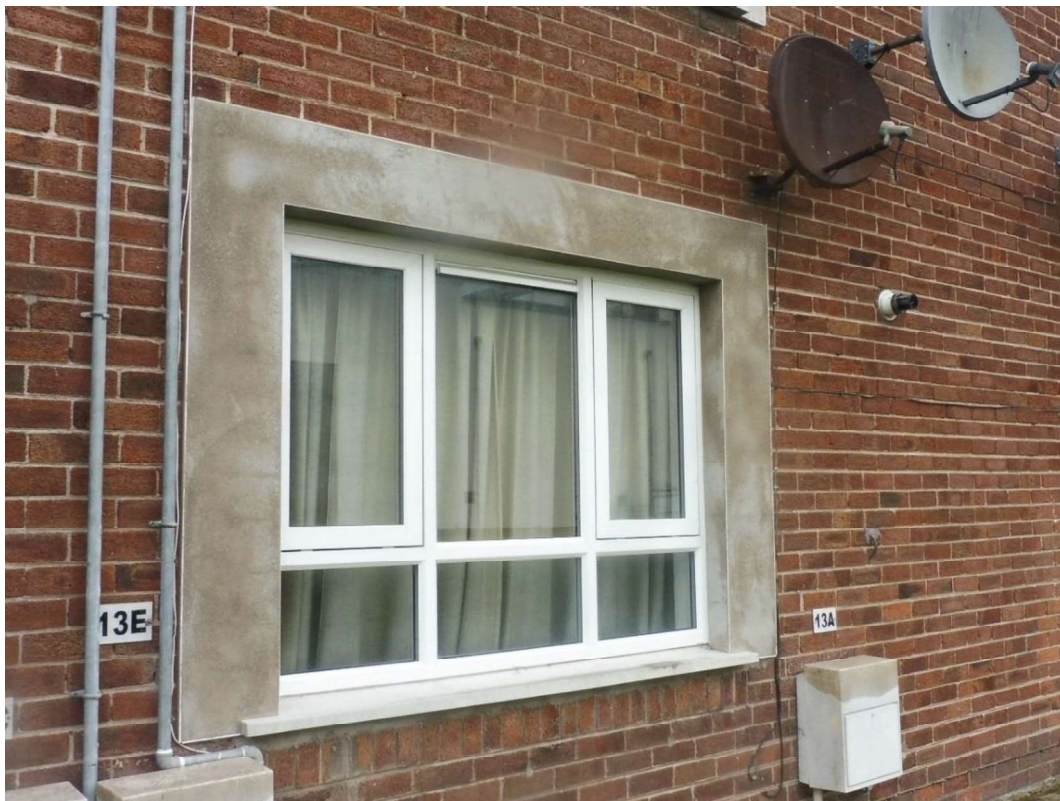
A few dwellings have had these precast concrete surrounds removed already (see photograph 19 below). Where wall finish is fair faced brickwork a self-finished render band has been provided around the top and sides of the window opening.

Figure 19 Window where concrete surround has been removed
