December 2022

## **Refurbishment works in the Sunnylands Estate, Carrickfergus**

### 2.03 External Walls – Condition

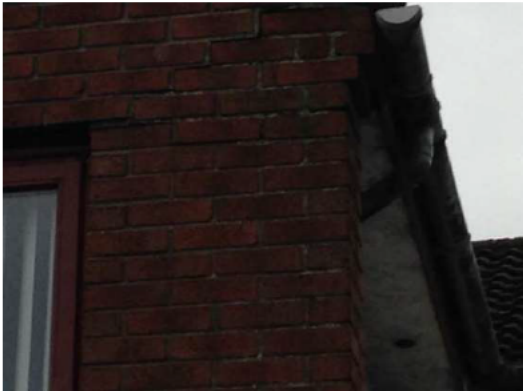
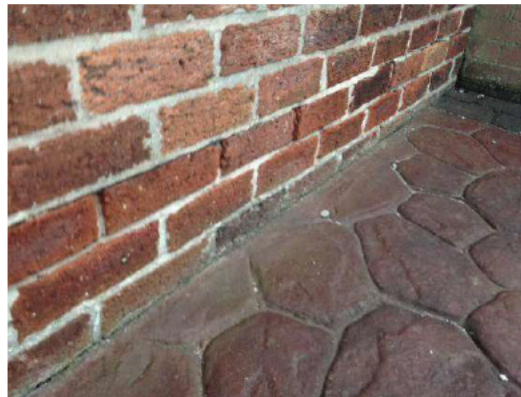
Facing brickwork is generally in satisfactory condition however sections of mortar pointing, particularly to exposed locations and below DPC level is in poor condition with sections friable.

NIHE District Office have advised that wet blown quilt cavity wall insulation is present to Bridewell Drive and Shaftesbury Cross flats. (The consultant has not carried out a borescope survey to confirm this.) (Refer also to 2.04.2.)

The brickworks to these blocks of flats has been previously repointed however the previous mortar, which is very friable, was not raked out sufficiently and is causing the new mortar to flake and fall out of the joints.

Painted smooth/textured render and dry dash render is generally in satisfactory condition with only a few minor areas of boast, loose, missing or cracked render which may allow water ingress.

Repoint brickwork to isolated area (240m<sup>2</sup>)

Repoint brickwork to all elevations of Bridewell Drive and Shaftesbury Cross flats (1025m<sup>2</sup>) (This will require scaffolding over the commercial units at the ground floor.)

NIHE to consider removal of existing defective blown quilt cavity wall insulation and replacement. **NIHE to confirm.**

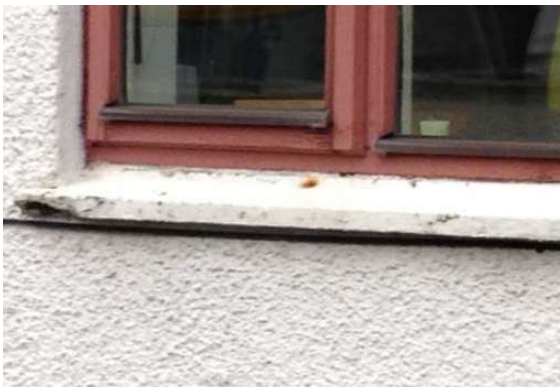
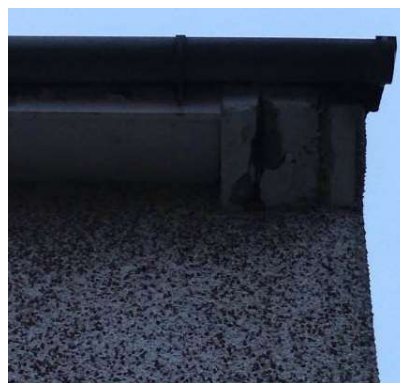
- I. Pre-cast concrete window cills and lintels are generally in satisfactory condition; however a small number of these are damaged and require repair work.
- II. Pre-cast concrete picture frame window surrounds are present to 12nr flats in Bridewell Drive and 48nr flats in Sunnylands Grove.

Nrs [REDACTED] Bridewell Drive and all the Sunnylands Grove flats have 1 nr concrete picture frame window surround around the living room window whereas Nrs [REDACTED] Bridewell Drive have a concrete picture frame window surround around the living room and gable windows. (64nr window surrounds in total)

The concrete picture frame window surrounds are generally in poor condition with cracking and spalling evident externally. We understand that these have been a constant source of tenant complaints due to draughts.

- I. Replace pcc window cill (24nr)
- II. Repair pcc window cill/lintel (32nr/780nr)

Remove existing concrete surrounds to all living room and gable windows with new traditional jamb, steel lintel and precast concrete cill to achieve better weatherproofing, eliminate cold bridging and risk of further concrete spalling to existing surrounds. Provide smooth render bands to heads and reveals externally (63nr). Replacement of concrete surrounds will necessitate replacement of windows affected as windows are fixed through the PVC framing directly into the concrete surrounds. To safely access the works, scaffolding will be required.

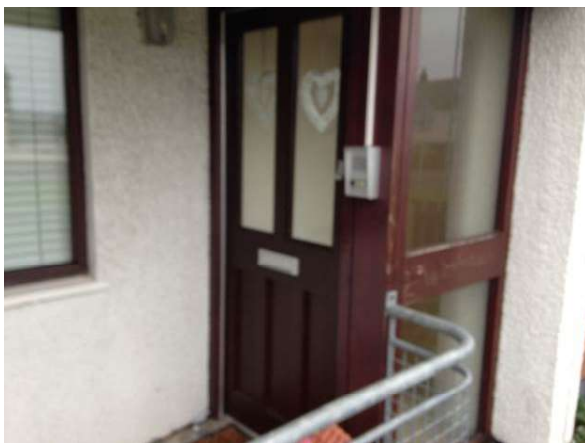
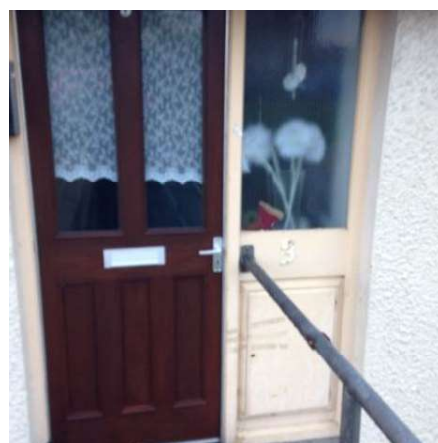
Many doors are twisted, splitting or delaminating compromising their integrity and allowing wind and water ingress. Tenants complained of draughts emanating from these doors.

Timber sidelights in many cases are decayed/damaged with joints opening up. Their integrity is affected and water penetrating joints will accelerate their decay.

Timber sidelights in some cases have single skin plywood lower panels and single glazed upper panels or both single glazed lower and upper panels. Tenants complained of excessive dampness/condensation internally causing mould growth around/on the plywood panelling.

In isolated instances the mastic seal around external doors has come away which may allow water ingress.
