**Our Ref: EIR 965**

## **TREE INSPECTION REPORT**

**Location:** 1 Laburnum Court, Comber

## Tree Survey

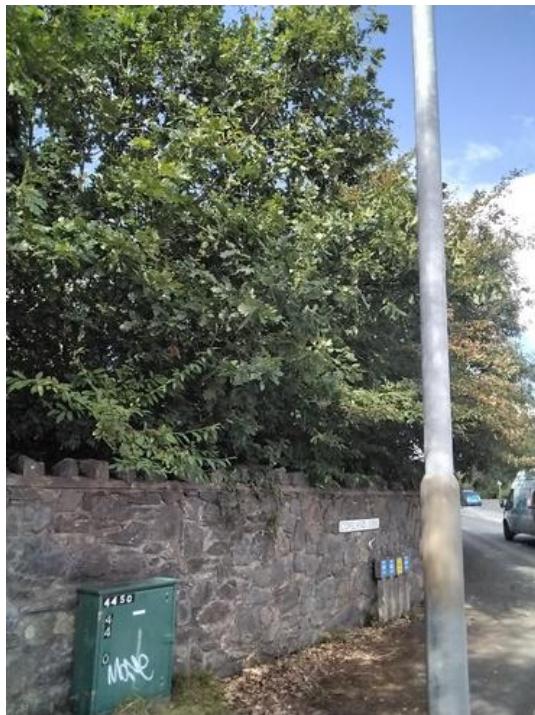
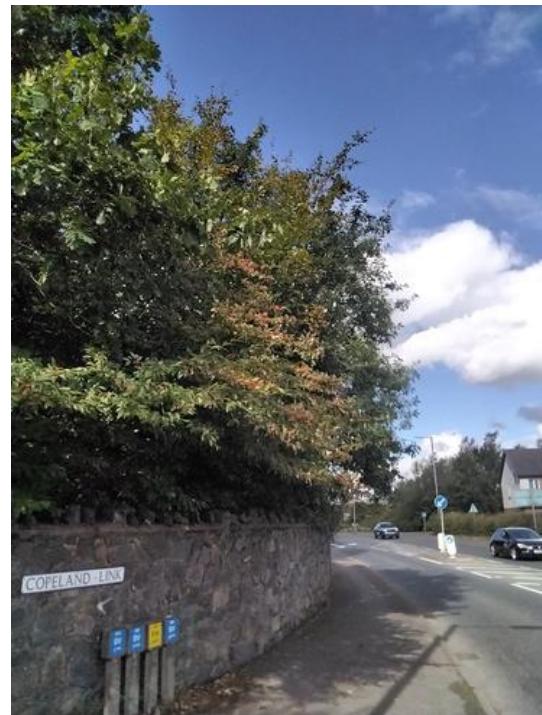
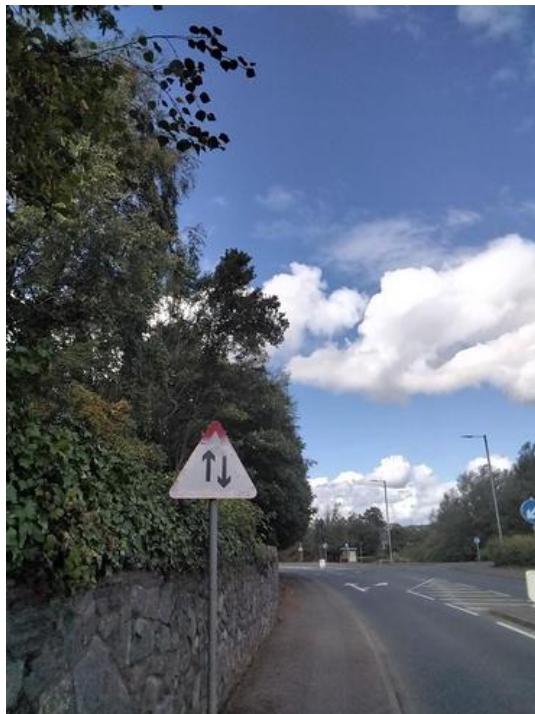
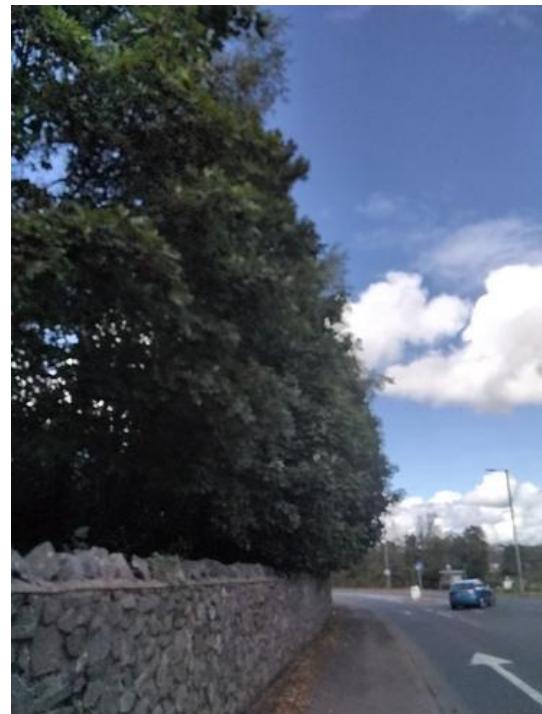
Roadside

Quercus rober / Oak

Acer pseudoplatanus /  
Sycamore

Betula Pendula / Silver Birch

Moderate

Side Trim

Ground to sky side trim x 17

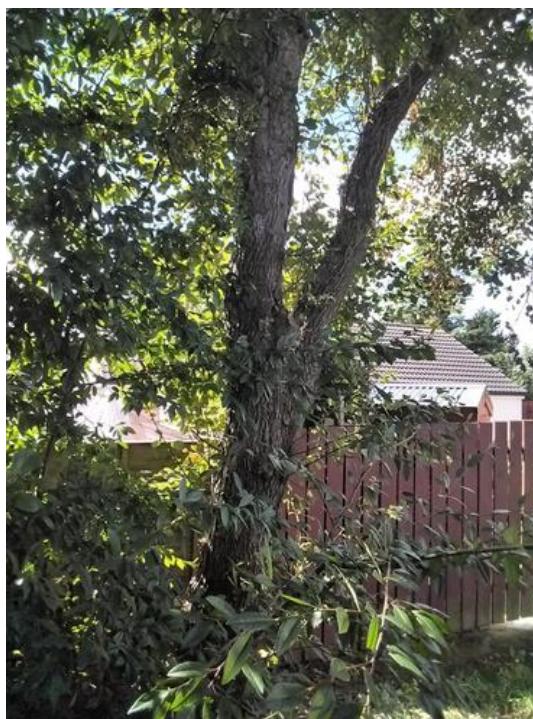
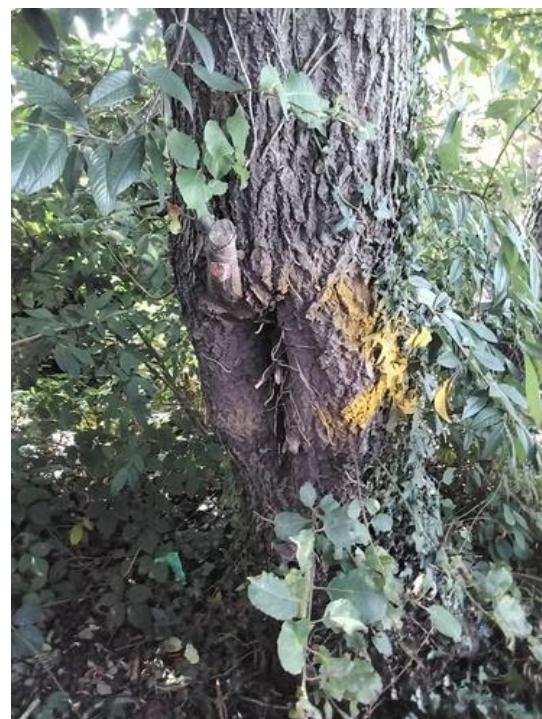
Willow x 2

Poor

Weak major unions. Cavity present on tree

Remove

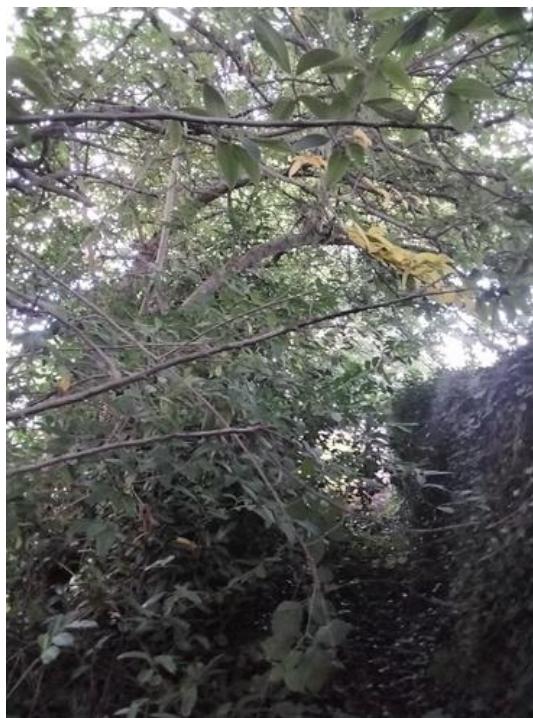
Photo 7

| Laurels x 3 | |
| <b>Condition</b> | Moderate |

| <b>Action</b> | Reduction |

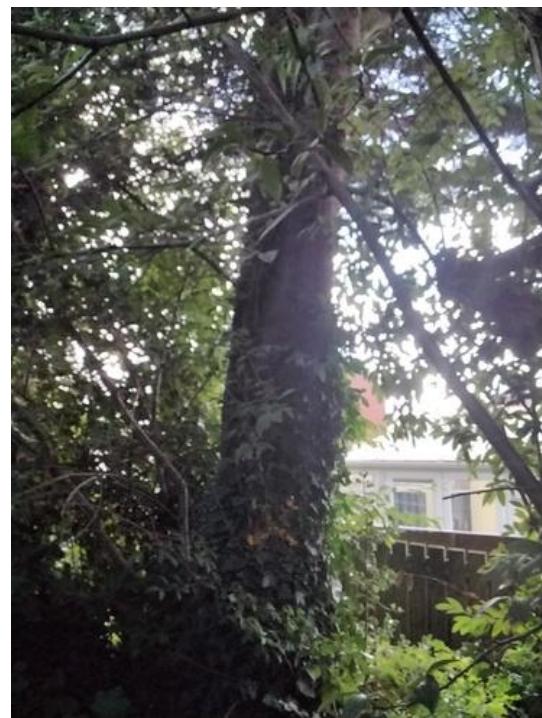
Photo 8

Castlewellan Gold x 1

Poor

Included bark in multi stem union at 1.5m

Remove

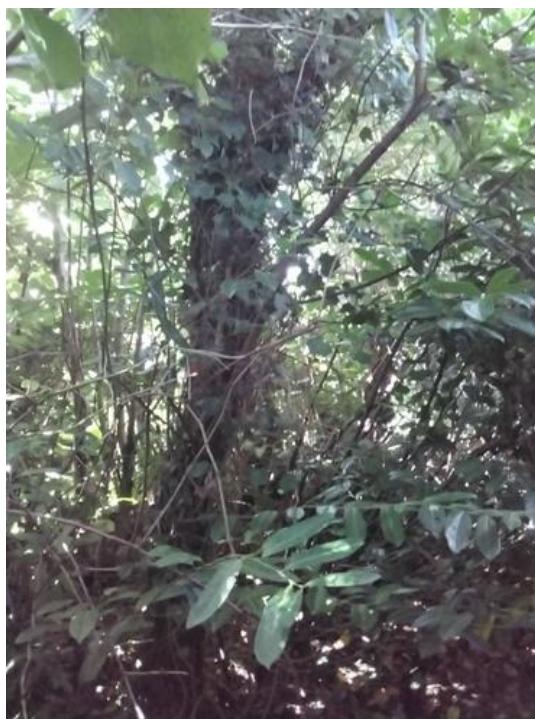
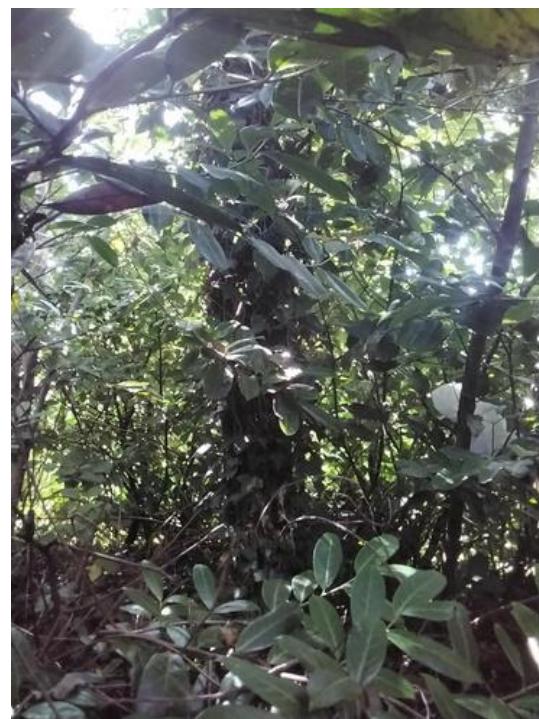
Willow x2

Poor

More than 50% deadwood in the crown of each tree.

Remove

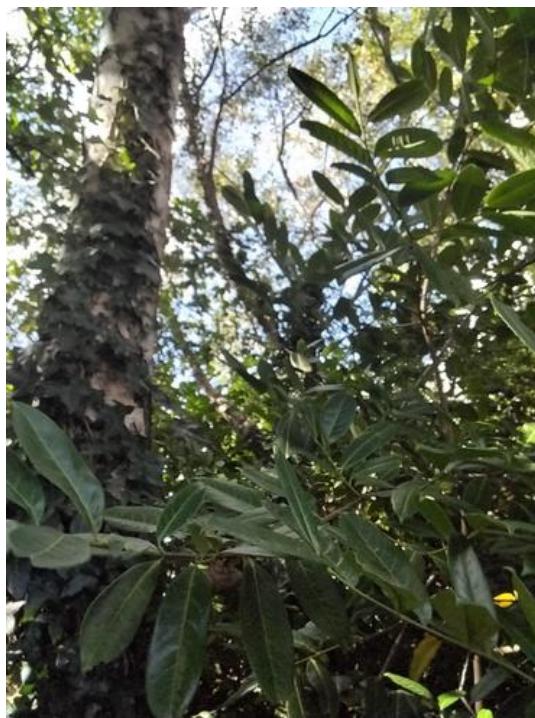
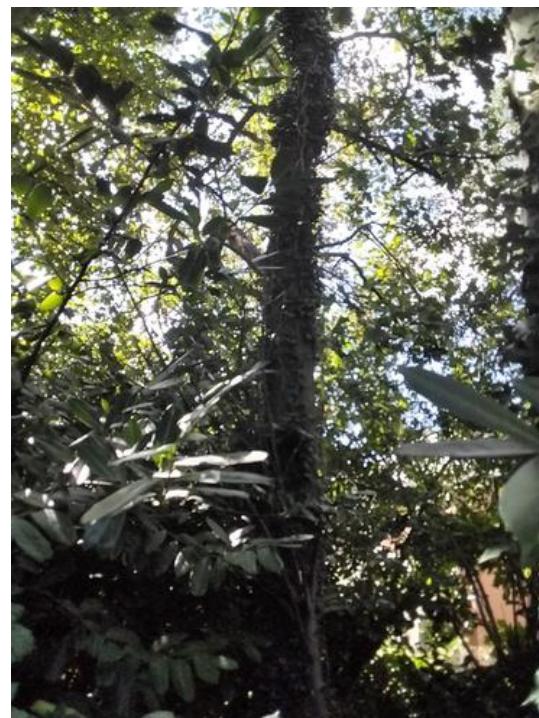
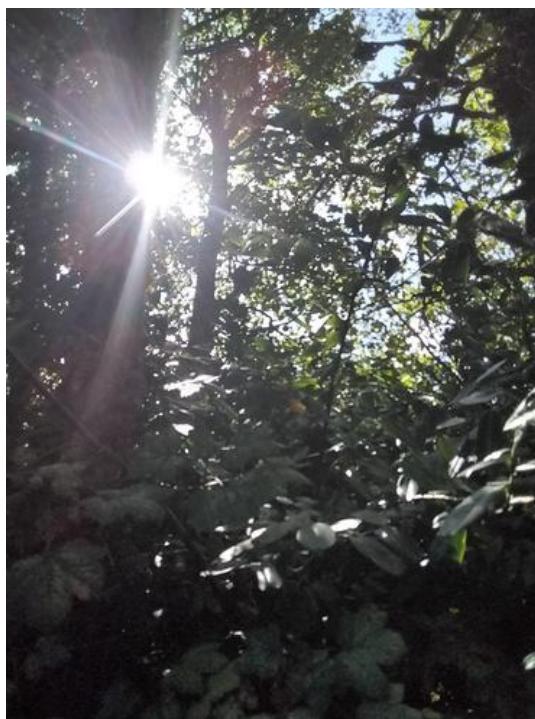
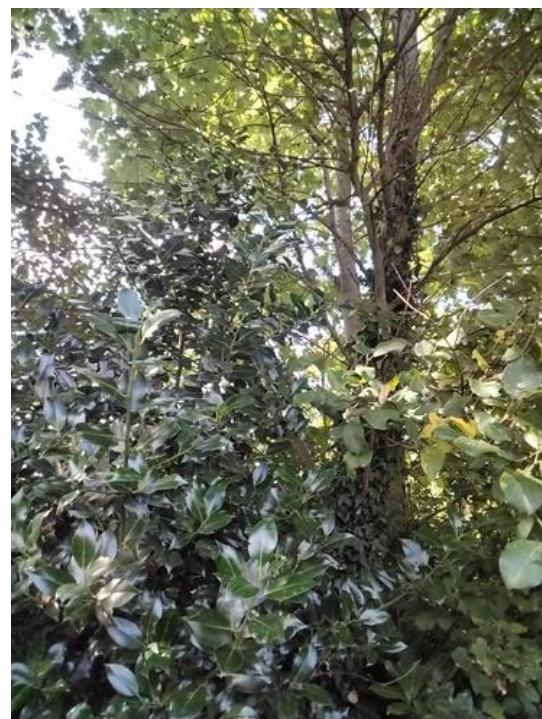
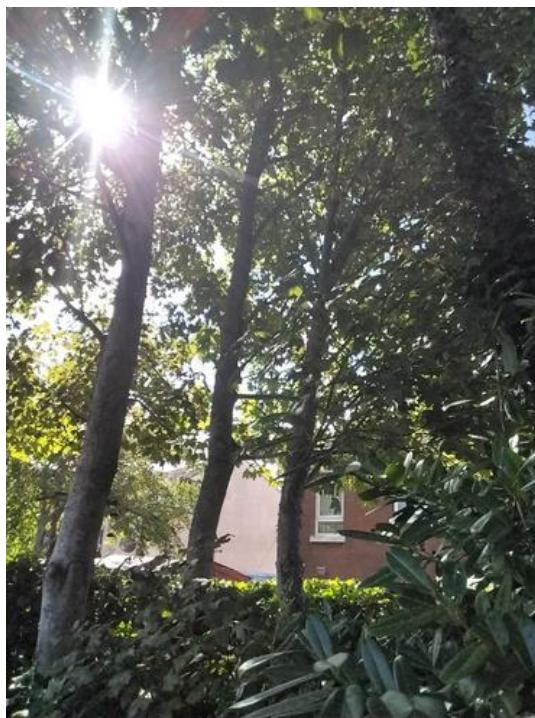
X 6 trees on boundary with properties

Moderate

Side Trim

Side trim to maintain boundary swathe

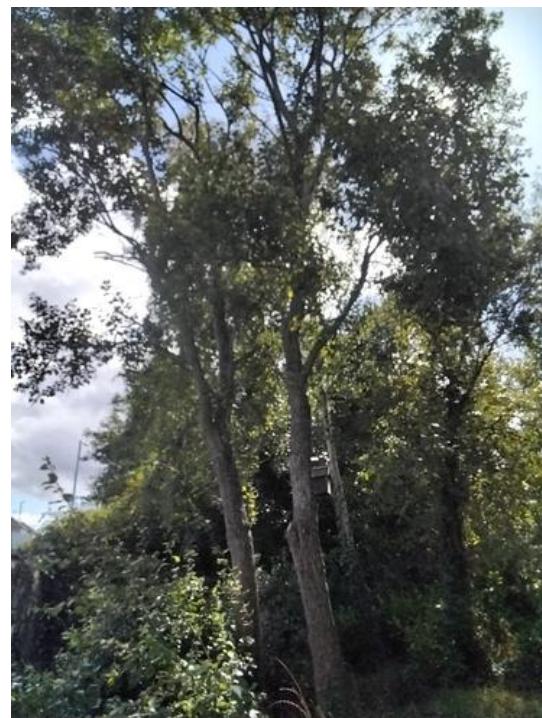
Photo 16

Willow x 2

| <b>Condition</b> | Poor |
| Significant dieback in Crown of both trees | |

| <b>Action</b> | Remove |

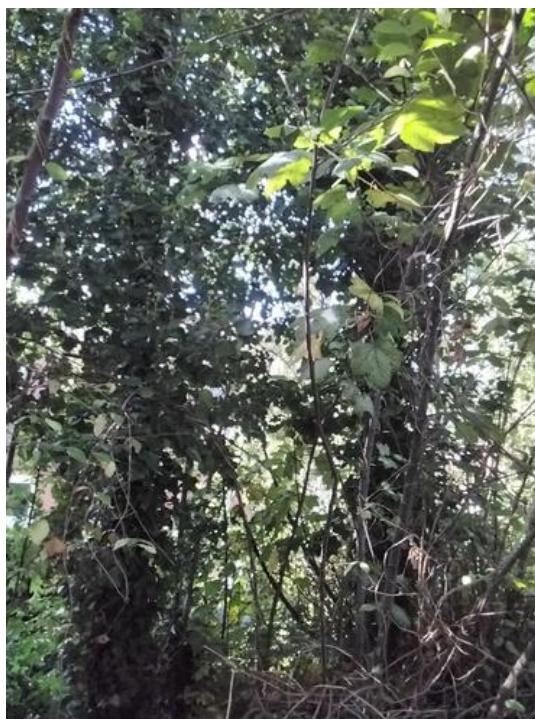
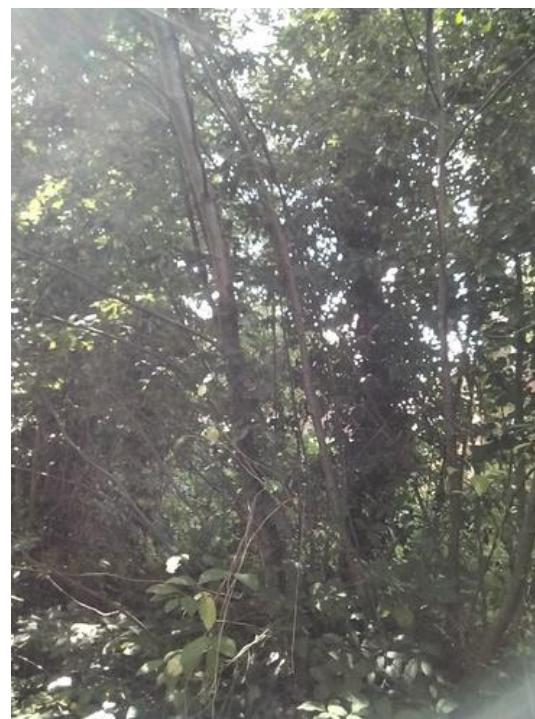
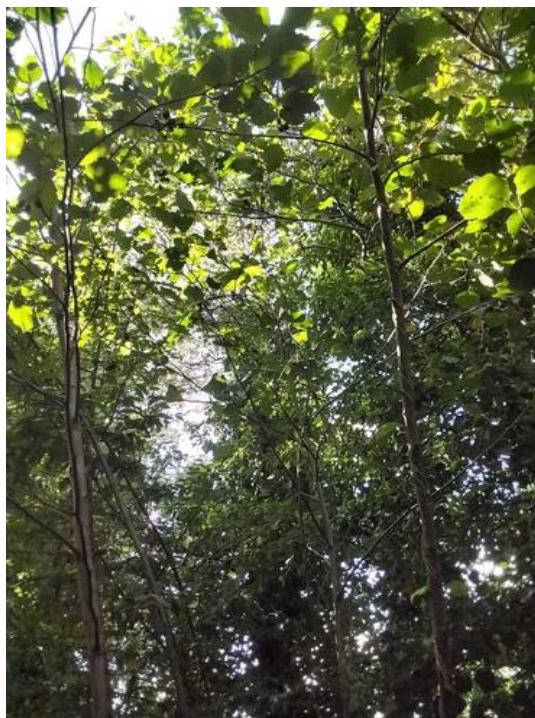
| <b>Condition</b> | Moderate |

| <b>Action</b> | Side Trim |

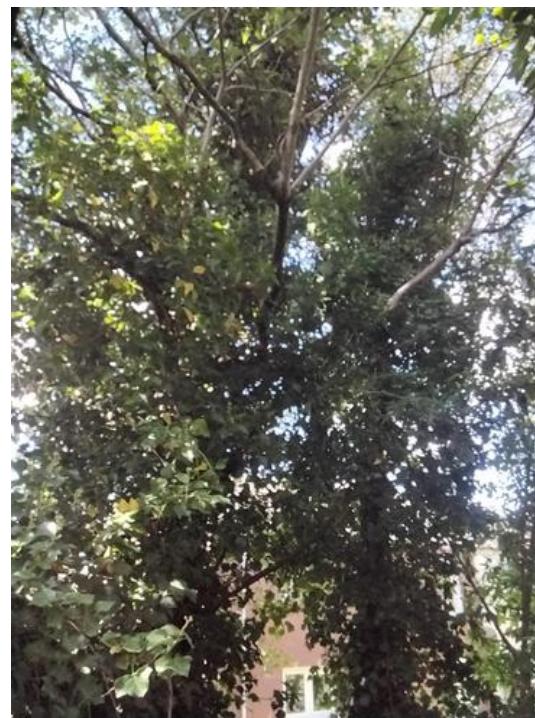
Photo 20

| <b>Species</b> | Alnus / Alder |
| <b>Condition</b> | Moderate |

| <b>Action</b> | Complete prune |
