# Journey to Retrofit

**REVIEW OF A PILOT SCHEME  
TO IMPROVE THE ENERGY EFFICIENCY  
OF SOCIAL HOUSING**

**Housing**  
Executive

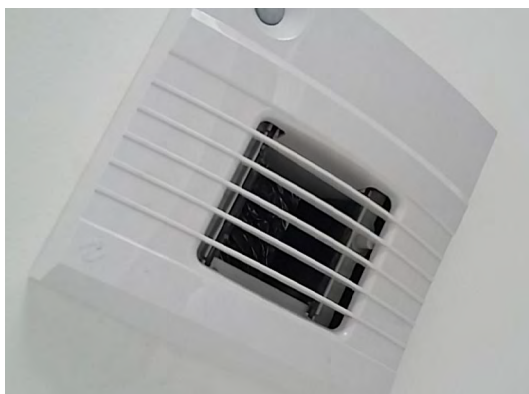
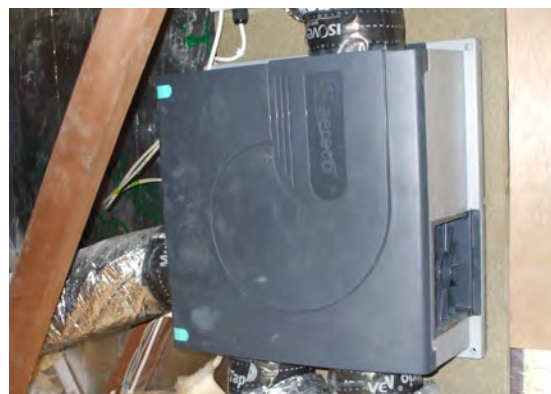
#### 5.4.1 Centralised Mechanical Extract Ventilation - CMEV

This is an Aereco system that consists of a centralised fan unit installed in the loft of House D. It requires ducting for extraction only, and demand-controlled supply inlets in each habitable room. These are provided in the form of trickle vents in this case, although wall mounted vents can also be used. The system utilises Aereco's Hygro control sensor that exploits the expansion

and contraction of a nylon strip when exposed to moisture, offering a natural and energy-free method of controlling the aperture size of ventilation grilles. Openings increase in size as humidity rises, allowing more fresh air when it is needed. Equally, the ventilation unit increases the rate of ventilation as it senses an increase in humidity. The unit has washable filters, so there is no expense in regularly replacing these, though as the unit is in the loft, access can be a problem. The performance does not depend on low air permeability and acoustically the unit is designed to operate at low noise levels (33dB(A) @ 40m<sup>3</sup>/h) to address the concern that occupants may find it a nuisance and have it disconnected.

Throughout the duration of the monitoring period, the occupants of House D have been very happy with the ventilation system. They have little interaction with it and allow it to operate as required. There was one incident recorded when the fan unit stopped working due to a blown fuse, and there are issues regarding who exactly is responsible for the regular maintenance to clean the filter. This is something that will need to be addressed in future schemes prior to the specification of similarly non-typical items.

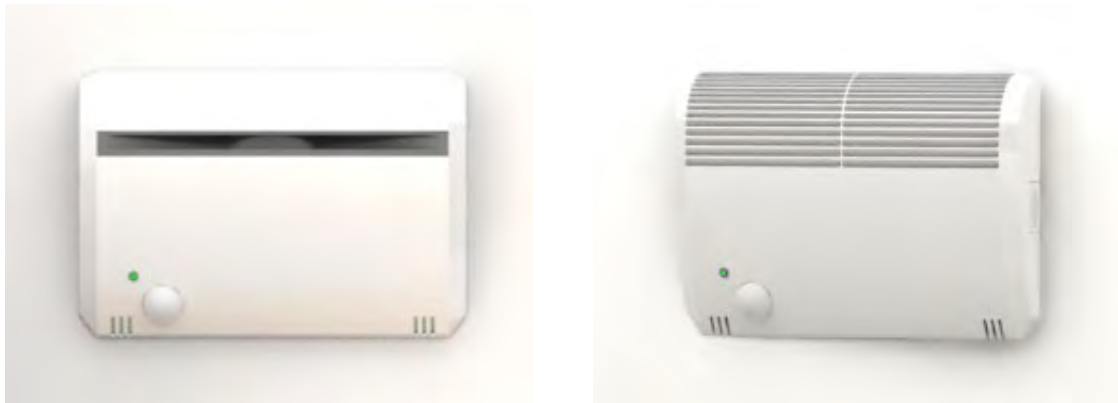
In House C, a de-centralised smart ventilation system called Think.Air was installed, which has been designed locally in Northern Ireland. Think.Air is a whole-house, balanced ventilation system that operates without ducting, supplies fresh filtered air into habitable rooms and extracts polluted air from the wet rooms.

As this is a prototype, real-life testing has enabled the developers to adjust and improve the system. The first installation proved the concept of airflow utilising re-purposed fans from proprietary ventilation units, with sensors incorporated to measure temperature and relative humidity. Initially, the system was connected to the cloud via the occupant's broadband router so that indoor environmental conditions could be displayed on a web-based dashboard. Problems with intermittent data transfer between the occupant's broadband router and the cloud were detected, so to bypass the need for the household to have broadband, cloud connection is now available via 4G and LoRaWAN.

From the outset, the occupants expressed an interest in trialling the ventilation system and gave valuable feedback, which led to adjustments and the development of new aspects and functions. The occupants reported fan noise from the first installation, so a new fan was developed and 3D printed which improved the balance of the impellers and reduced the noise. Another problem encountered was that the occupants would block off the ventilation units to prevent excessive, cooler, fresh air being supplied into the house, particularly during times of

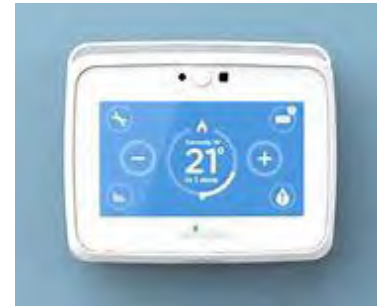
In the four Housing Executive homes, a Switchchee Smart Thermostat was installed. This is an autonomous space and hot water heating controller that learns the occupant's routines over time. It has a simple, easy to use interface, it records temperature and humidity at the unit itself and it displays the data it gathers via an on-line dashboard (Fig. 5.1). Information is displayed on the dashboard for each property such as how quickly the house gains or loses 1°C, the risk of mould and the average temperature and humidity, as well as the latest sensor reading. The home page of the dashboard displays comparative information for all houses where the client has Switchchee units installed. It ranks the properties in terms of the highest mould risk, most at risk of fuel poverty, highest humidity and the most at risk of overheating.

This data allows Landlords to see at a glance if there are any issues, so they can be dealt with in a timely manner and before any severe, moisture-related defects emerge. Coupled with the ability to contact the occupant to arrange visits and even to test the boiler remotely, having access to internal sensor data in this way is a great step towards the smart management of fuel consumption, improving occupant comfort levels and Landlord's maintenance obligations.

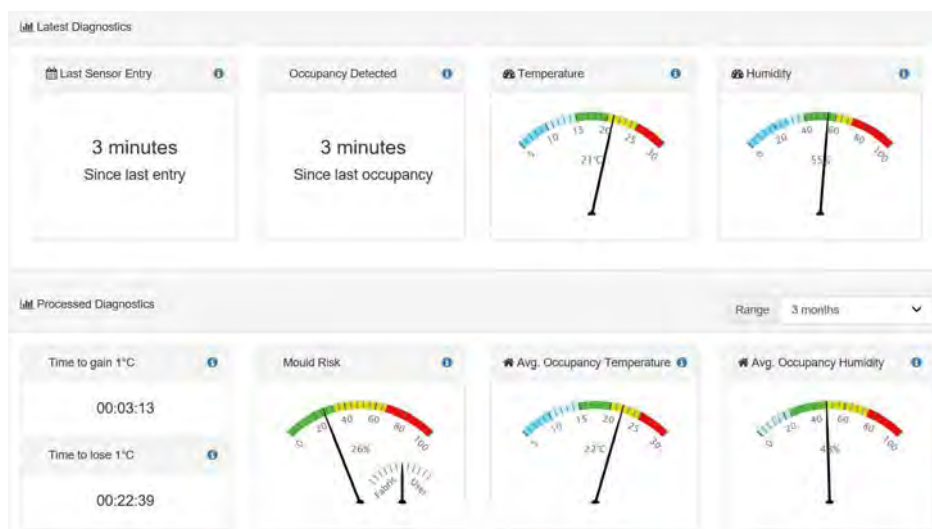
**Figure 5.1: Switchchee Dashboard**

Perhaps the most intuitive aspect of the Switchchee is the inter-dependence between data collection and heating controls. This addresses problems of occupant interference that Landlords face when introducing any new technology into their homes. Occupants are less likely to disable a system connected to the heating controls than if it was a standalone system, thus increasing the chances of gathering continuous data.

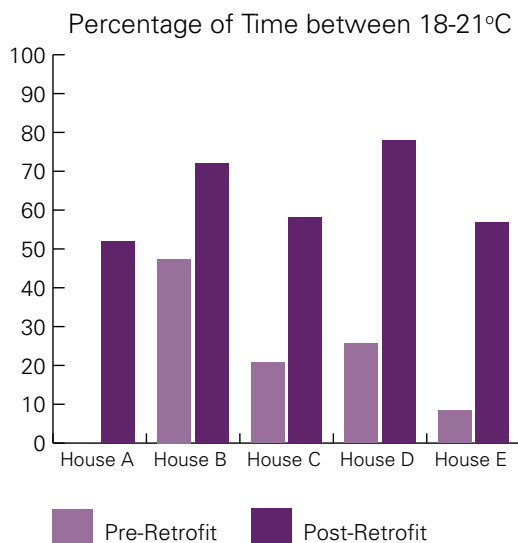
**Fig 6.1: Difference between Pre and Post Retrofit Temperature**

The graphs show the performance of each property. Overall, the houses spent an average of 63.3% of time between 18-21°C, an improvement of 37.8%. The humidity levels sat between 40-70% for 97.2% of the time, a 22% improvement on the pre-retrofit data.

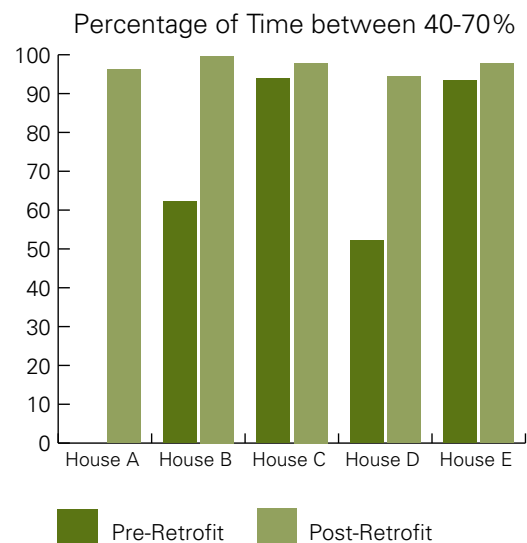
**Fig 6.2: Difference between Pre and Post Retrofit Relative Humidity**

Referring specifically to House D, this property experienced the greatest improvement in relative humidity with an increase of 42.3% in the time spent within the desired parameters. Notably, there was a change of tenancy between pre-retrofit and post-retrofit monitoring. Differences in occupant behaviours may have contributed somewhat to the change in humidity levels, but this is unlikely to have had as great an impact. Considering the air permeability of this house has decreased by 13m<sup>3</sup>/(h.m<sup>2</sup>), the amount of uncontrolled air infiltration has been significantly reduced. This potentially could have resulted in high humidity levels and moisture problems if left unaddressed, but has been mitigated by introducing the demand-controlled ventilation, which manages the moisture and maintains a comfortable humidity level.

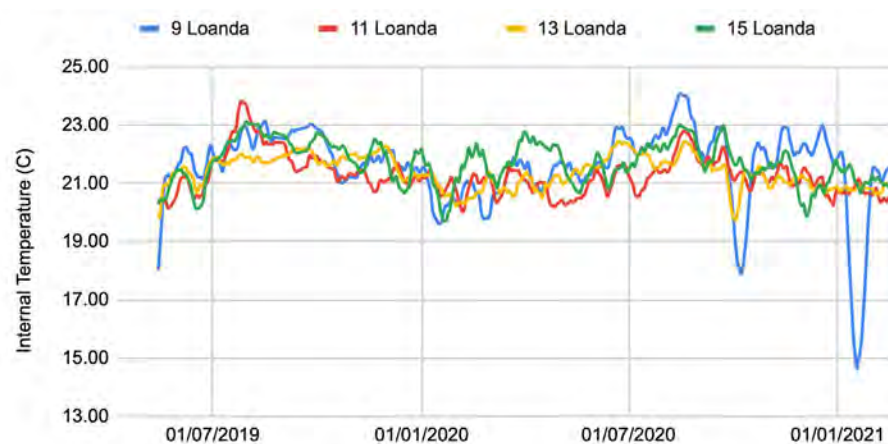
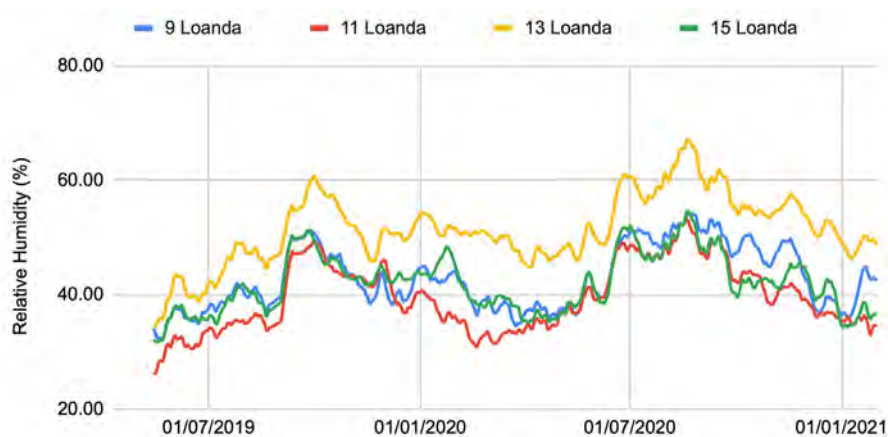
**Fig. 6.3 Switchee Data - Temperature and Humidity**

The graphs in Fig. 6.3 have been generated from data collected by the Switchee unit from July 2019 to January 2021, and these along with additional graphs and comparisons drawn between House B and House D can be found in Appendix D.

The Switchee Analyst has drawn the following conclusions from data analysed:

*House B has comfortably the lowest absolute and relative humidity across the year and in winter. This could be because they use their heating the most in winter.*

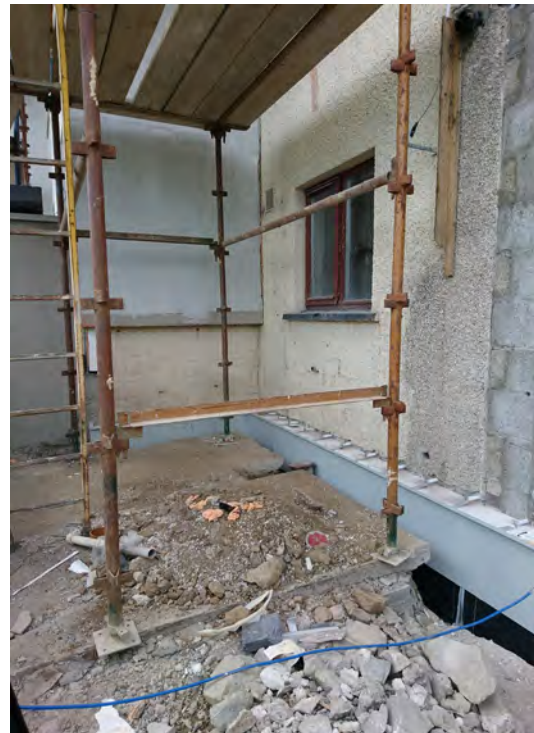
House D:

210mm EWI and 170mm thick x 400mm deep expanded polystyrene insulation fixed below DPC

The internal surface temperature at the floor/wall junctions of Options A & B increase in both options by 1.0°C and 1.4°C respectively, compared with the pre-retrofit detail.
