**BS 8414-1:2002 test on a  
Piperhill Construction  
External Rainscreen  
system with Vinylit  
Cladding**

13 November 2013  
Test report number 287918  
Issue 2

BS 8414-1:2002 External Rain screen system with Vinylit Cladding

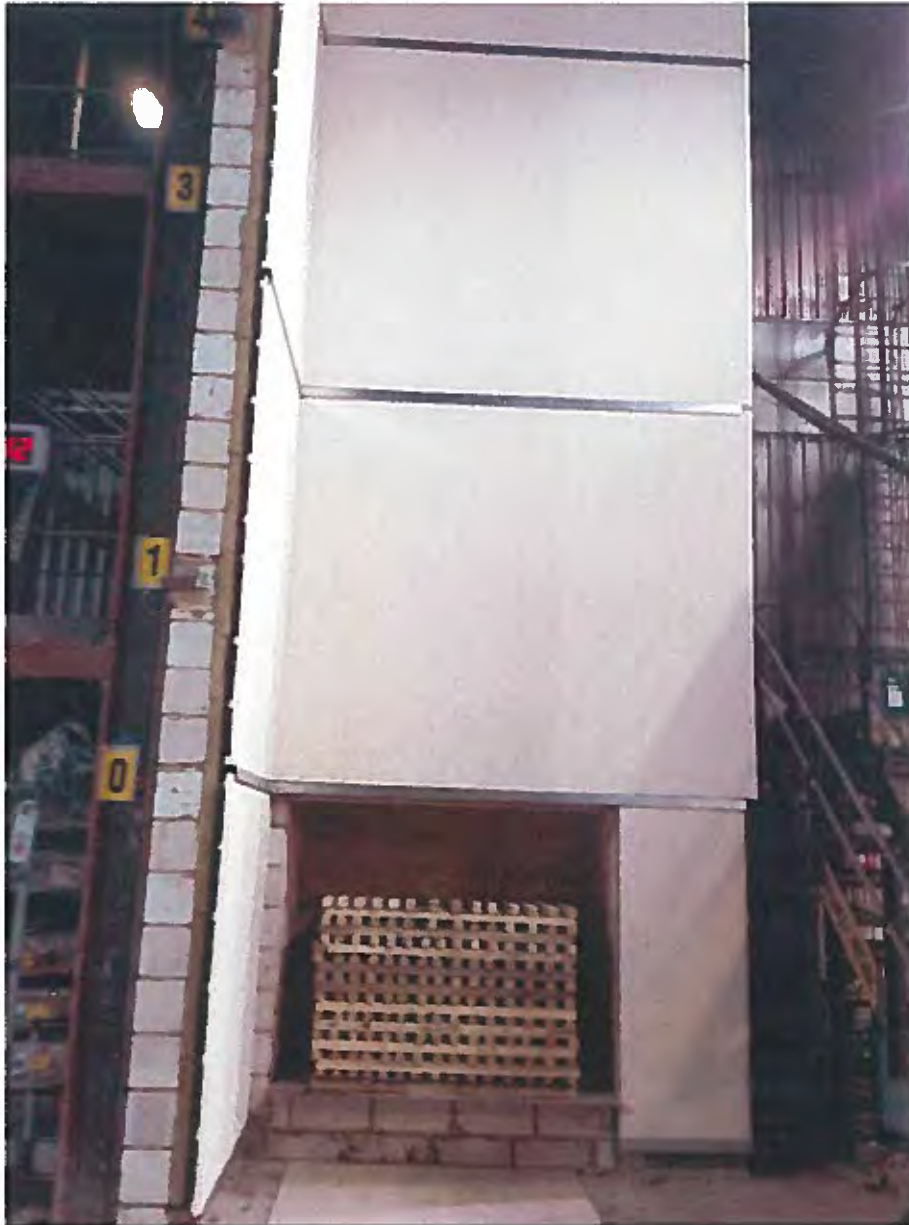
Figure 4. Photograph of system prior to test.

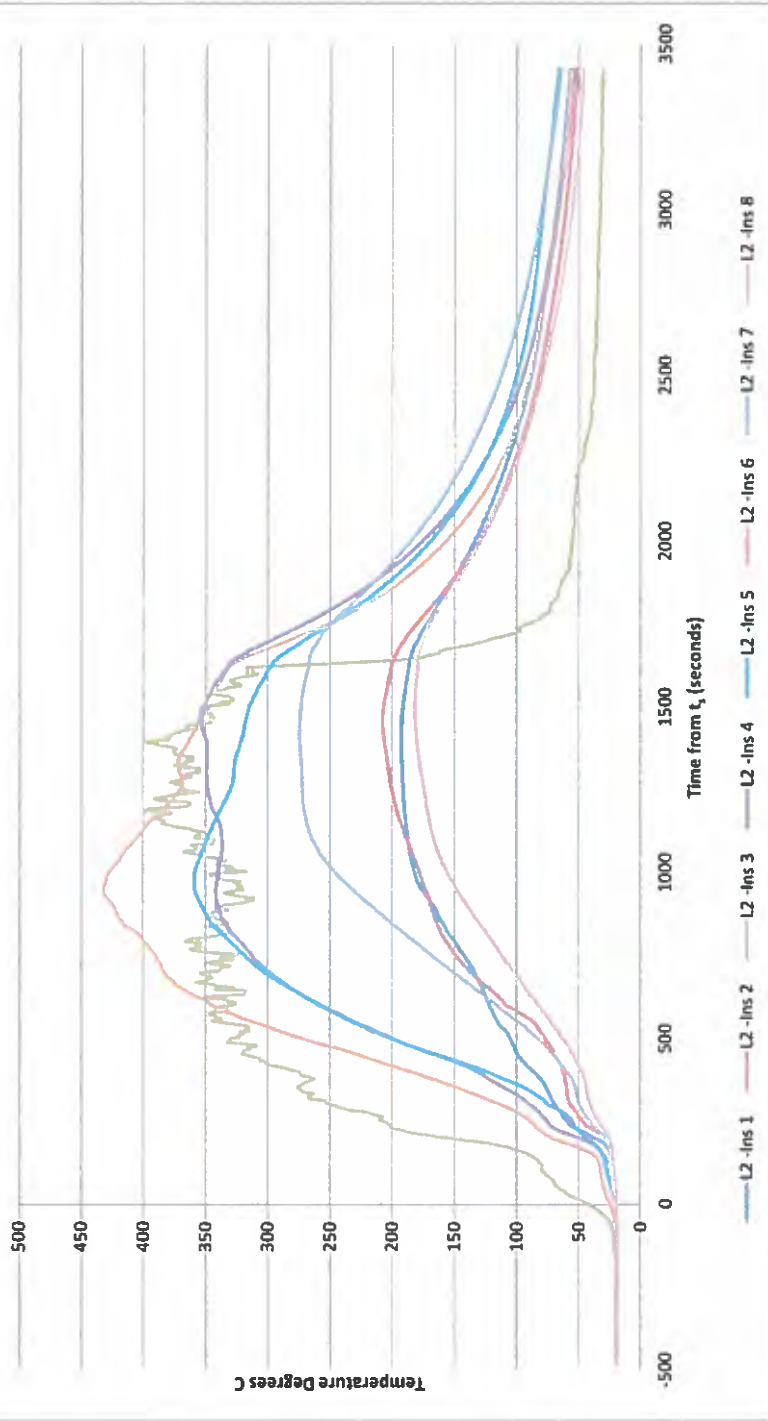
Figure 10. Graph of insulation board temperatures for level 2 from  $t_s$

**Piperhill Construction  
External Rainscreen with Vinylit Cladding  
Level 2 Insulation Temperatures**

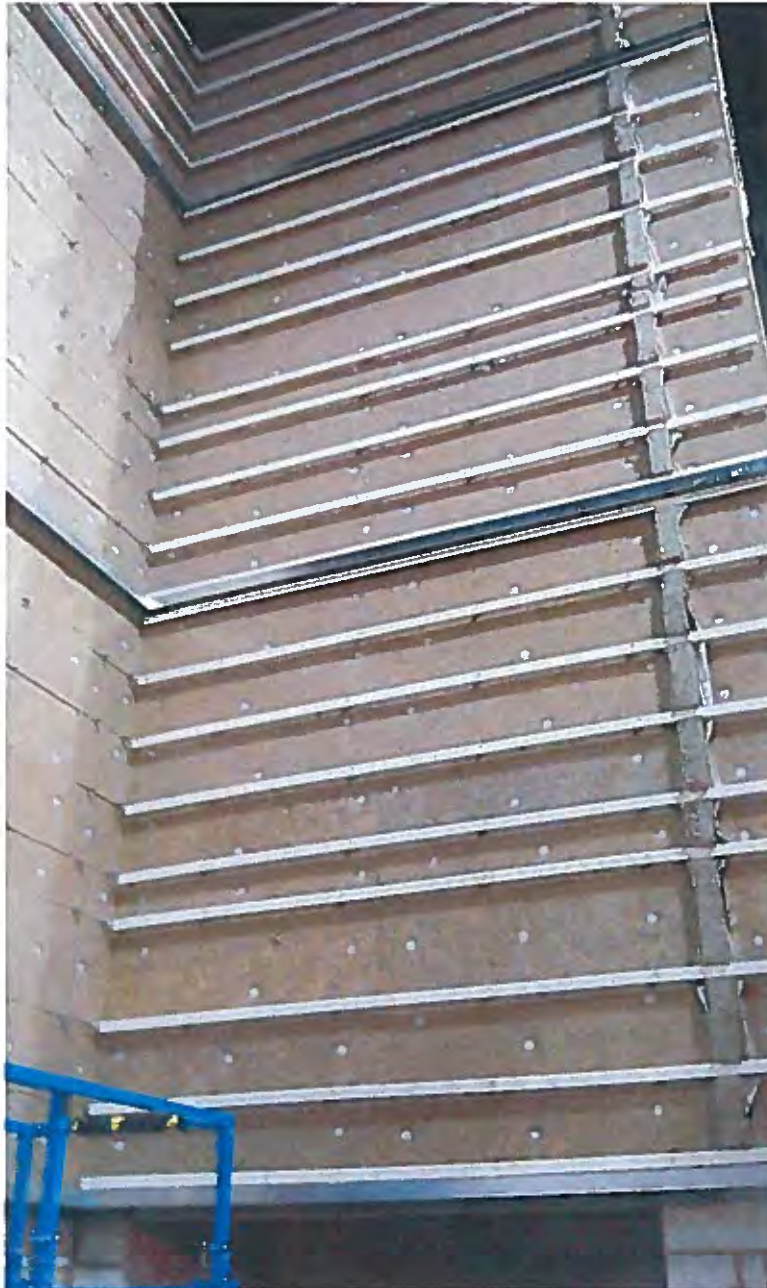
**Figure 1. Photograph of the system during construction – Insulation, Cladding rails, horizontal and vertical fire breaks**

The vertical fire breaks consisted of a rockwool SP60 Firestop slab of 75mm x 650mm x 1000mm, mechanically fixed on Rockwool SP/L fixing brackets, vertically on the main wall only, nominally 2.4m from the internal corner and 150mm from the outside vertical edge line of the combustion chamber. However, the barrier was perforated by the plastic cladding rails in a number of places throughout the full height of the installation; this can be seen in Figure 1.

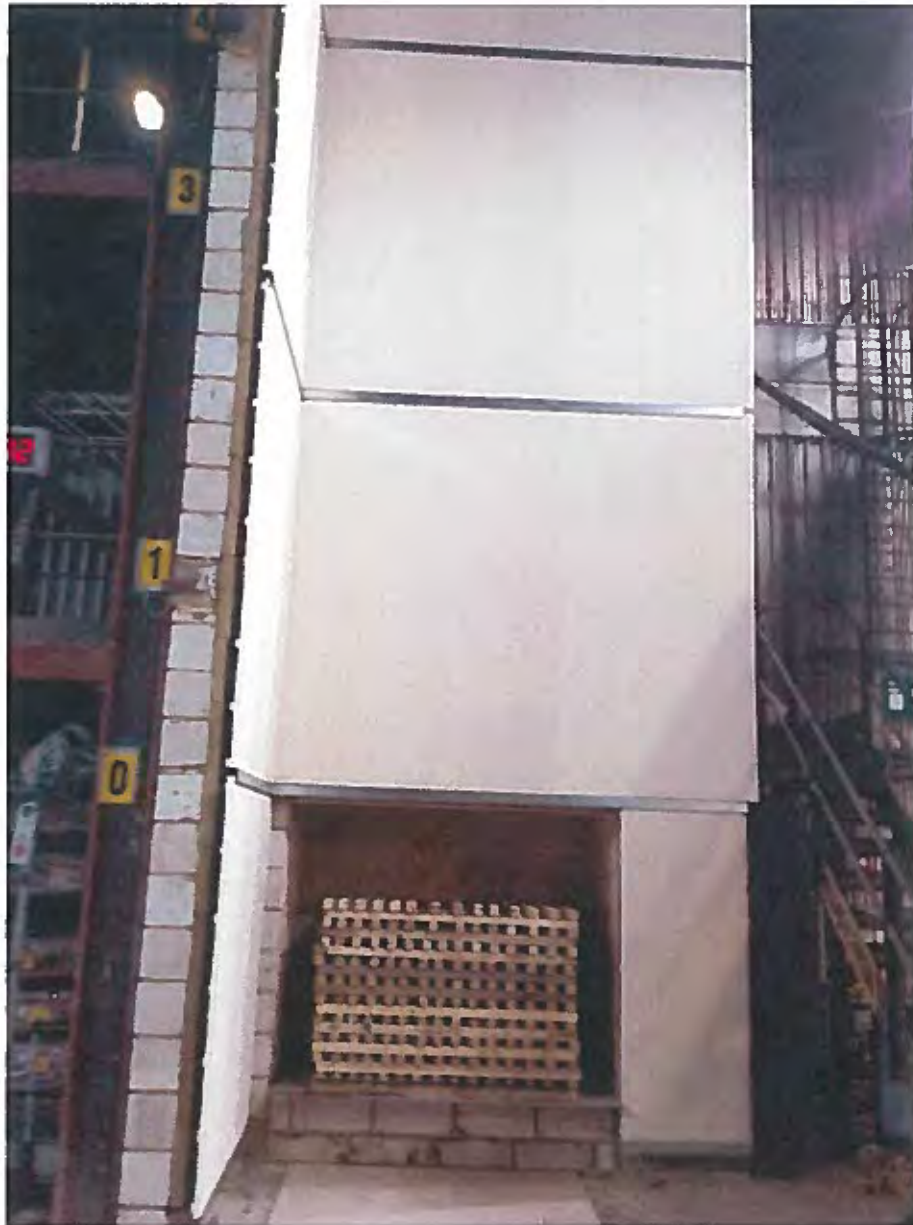
**Figure 2. Photograph of system prior to test.**
