**Our Ref: EIR 965**

## **TREE INSPECTION REPORT**

**Location:** 1 Laburnum Court, Comber

## Tree Survey

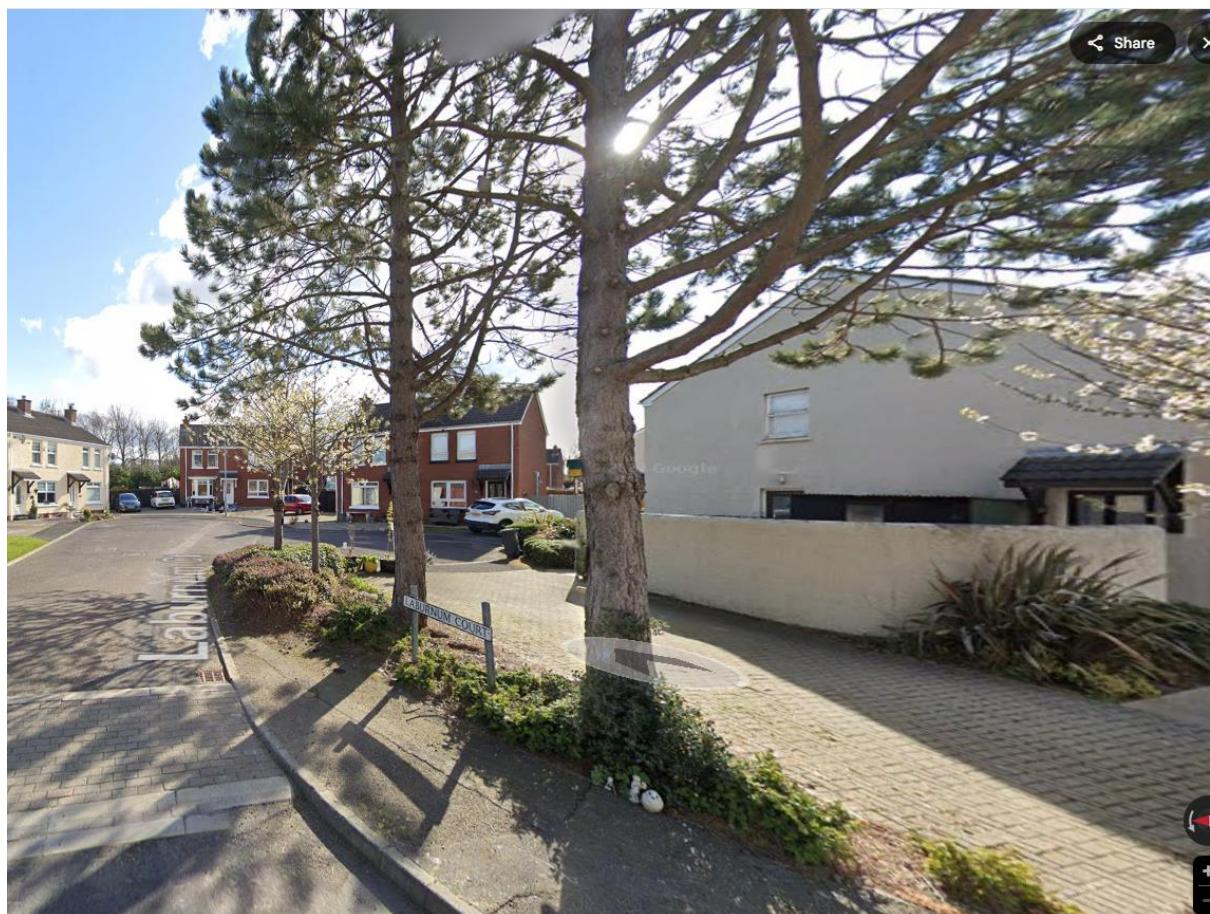
A visual inspection was conducted on two Scots Pine trees located on the opposite side of the street from the front of the property at 1 Laburnum Court, Comber. The assessment was carried out to evaluate the condition, structural integrity, and any potential risks associated with these trees.

- This tree was found to be significantly road-side heavy, with a noticeable imbalance in crown structure. ↗
- The uneven weight distribution increases the risk of failure, particularly in high winds or adverse weather conditions.
- There is a potential hazard to pedestrians, vehicles, and nearby properties due to the tree's positioning and structural imbalance.
- **Recommendation: Fell due to safety concerns.**

- This tree is currently sheltered; however, it would be exposed to increased wind loading and environmental stresses following the removal of Tree 1.
- The newly exposed position could lead to instability and a higher risk of failure over time.
- **Recommendation: Fell to mitigate future risks.**

- No significant signs of disease or decay were observed in either tree.
- The surrounding infrastructure (road, footpath, and property boundaries) does not currently show any visible damage from the trees; however, proactive removal is advised to prevent future structural issues.
- If required, traffic management measures should be implemented during felling operations to ensure public safety.

Given the findings of the inspection, the overall recommendation is to fell both trees to eliminate immediate and future risks associated with their structural integrity and environmental exposure.

- Consideration should be given to replanting suitable replacement trees in an alternative location, if required, to maintain the environmental and aesthetic value of the area.

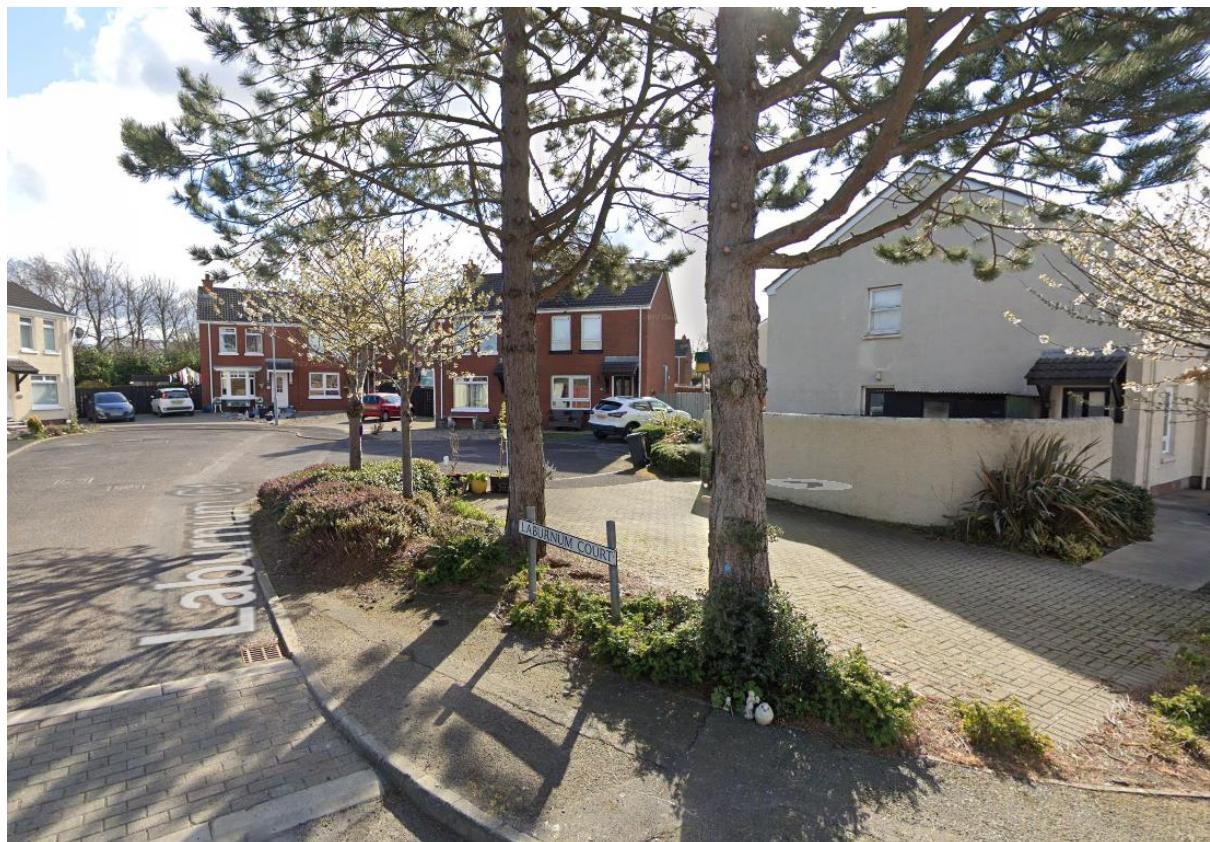
**Any history/cuts/damage:** Minor pruning wounds visible

**Soil condition:** Slight compaction from pedestrian use

Physical damage: Minor mower scuff marks

Comments: Minimal deadwood, not currently hazardous ˘
