December 2022

## **Refurbishment works in the Sunnylands Estate, Carrickfergus**

### 2.03 External Walls – Condition

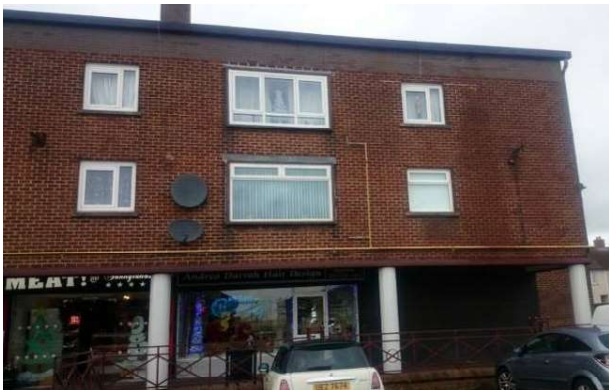
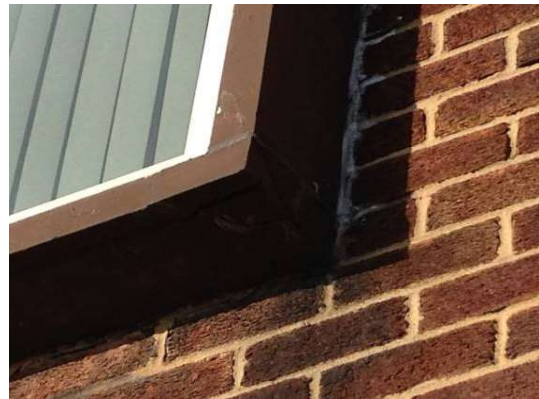
- I. Pre-cast concrete window cills and lintels are generally in satisfactory condition; however a small number of these are damaged and require repair work.
- II. Pre-cast concrete picture frame window surrounds are present to 12nr flats in Bridewell Drive and 48nr flats in Sunnylands Grove.

The concrete picture frame window surrounds are generally in poor condition with cracking and spalling evident externally. We understand that these have been a constant source of tenant complaints due to draughts.

Remove existing concrete surrounds to all living room and gable windows with new traditional jamb, steel lintel and precast concrete cill to achieve better weatherproofing, eliminate cold bridging and risk of further concrete spalling to existing surrounds. Provide smooth render bands to heads and reveals externally (63nr). Replacement of concrete surrounds will necessitate replacement of windows affected as windows are fixed through the PVC framing directly into the concrete surrounds. To safely access the works, scaffolding will be required.

Refer to Appendix D for existing and proposed details. (Bridewell Drive 12nr flats/16nr windows) (Sunnylands Grove 48nr flats/48nr windows)
