**APPENDIX 5 - PROGRESSIVE FIRE RISK ASSESSMENT ACTION PLAN ISSUES - HOUSING EXECUTIVE TOWER BLOCKS @ JANUARY 2018**

## **APPENDIX 6 - BUILDING REGULATIONS - RELEVANT REQUIREMENTS AND GUIDANCE**

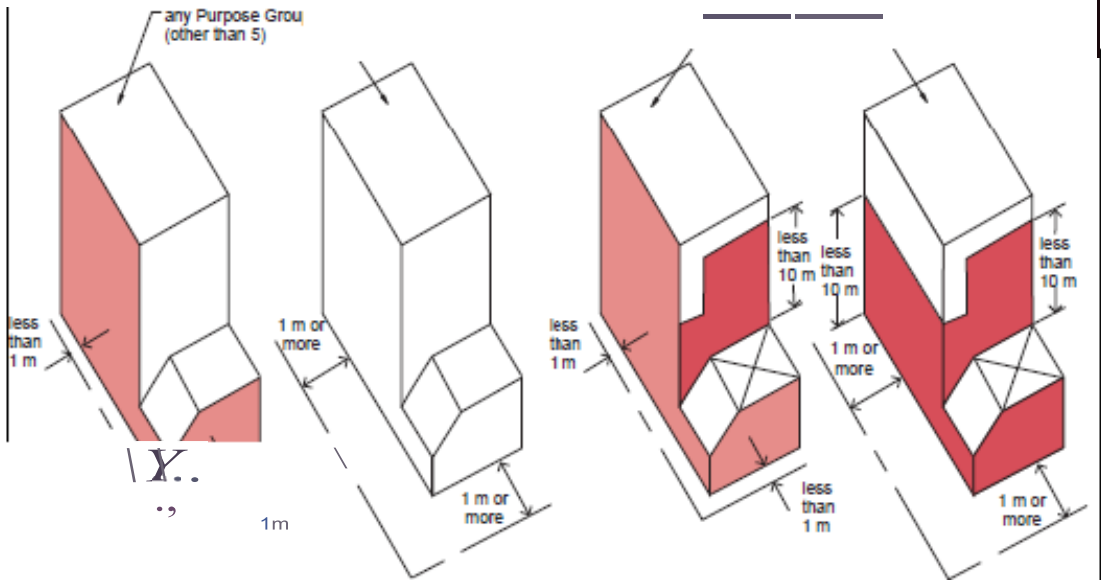
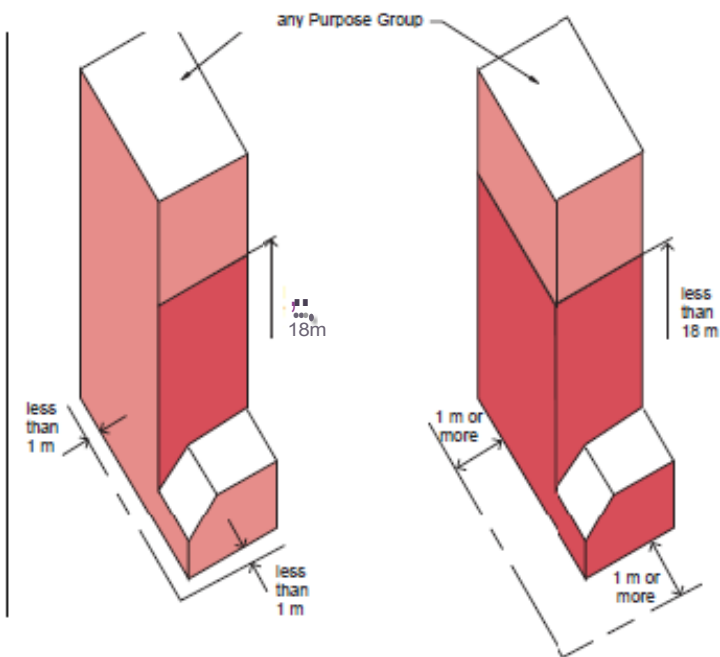
**Diagram 5.1 Provisions for external surfaces of walls**

see para 5.3

Maximum height of building - less than 18m

Maximum height of building - 18m or more

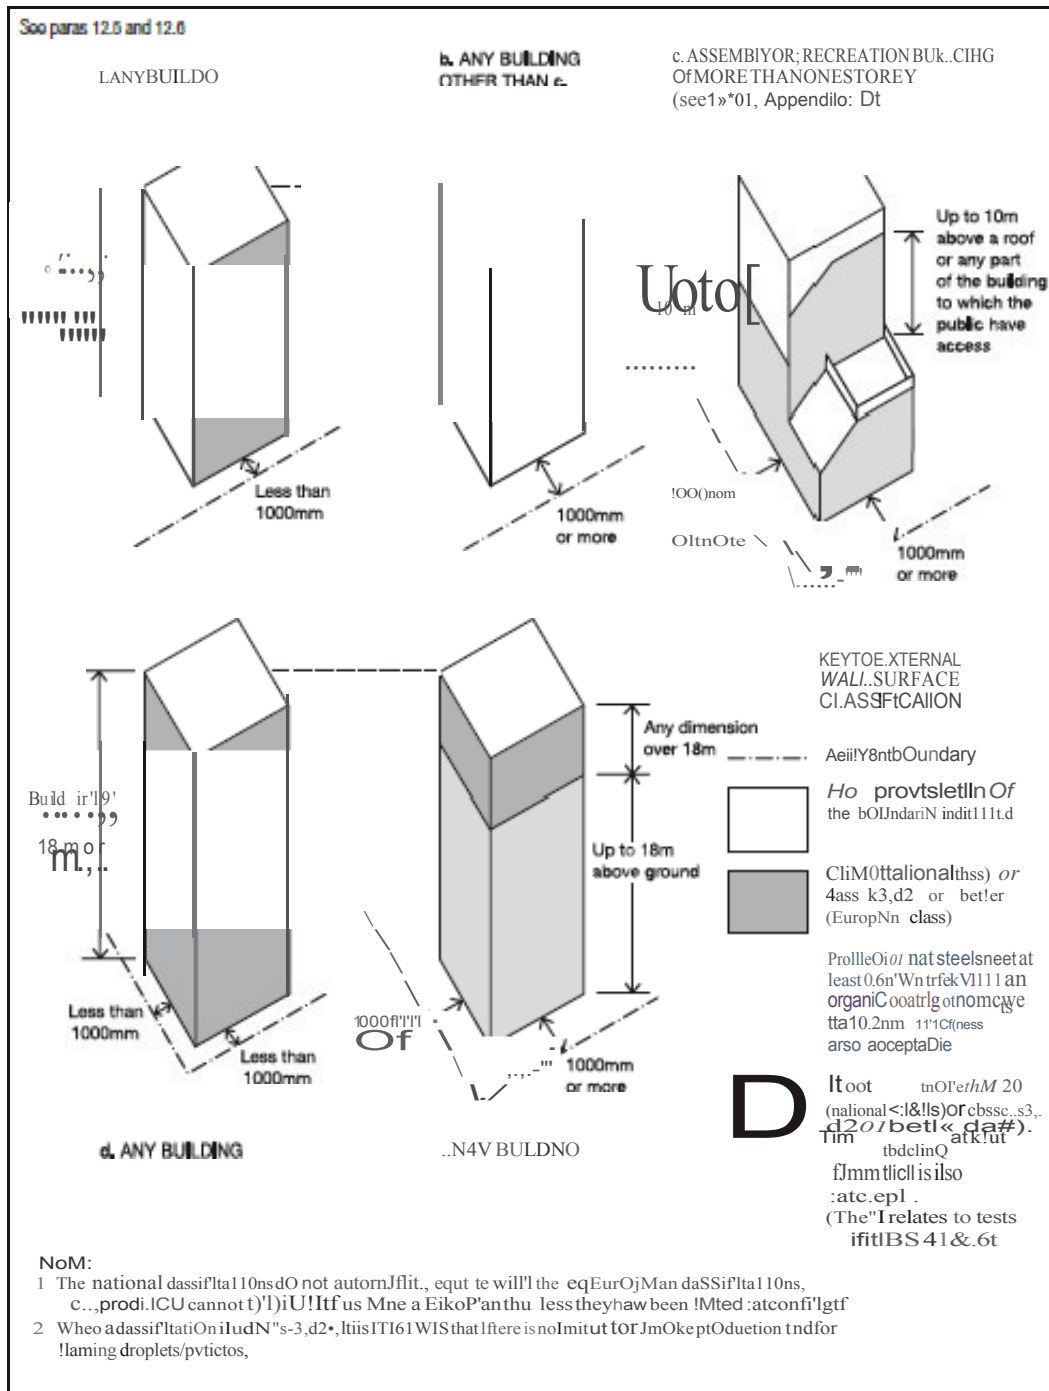
Diagram 40 Provisions for external surfaces or walls

CONSTRUCTION OF EXTERNAL WALLS

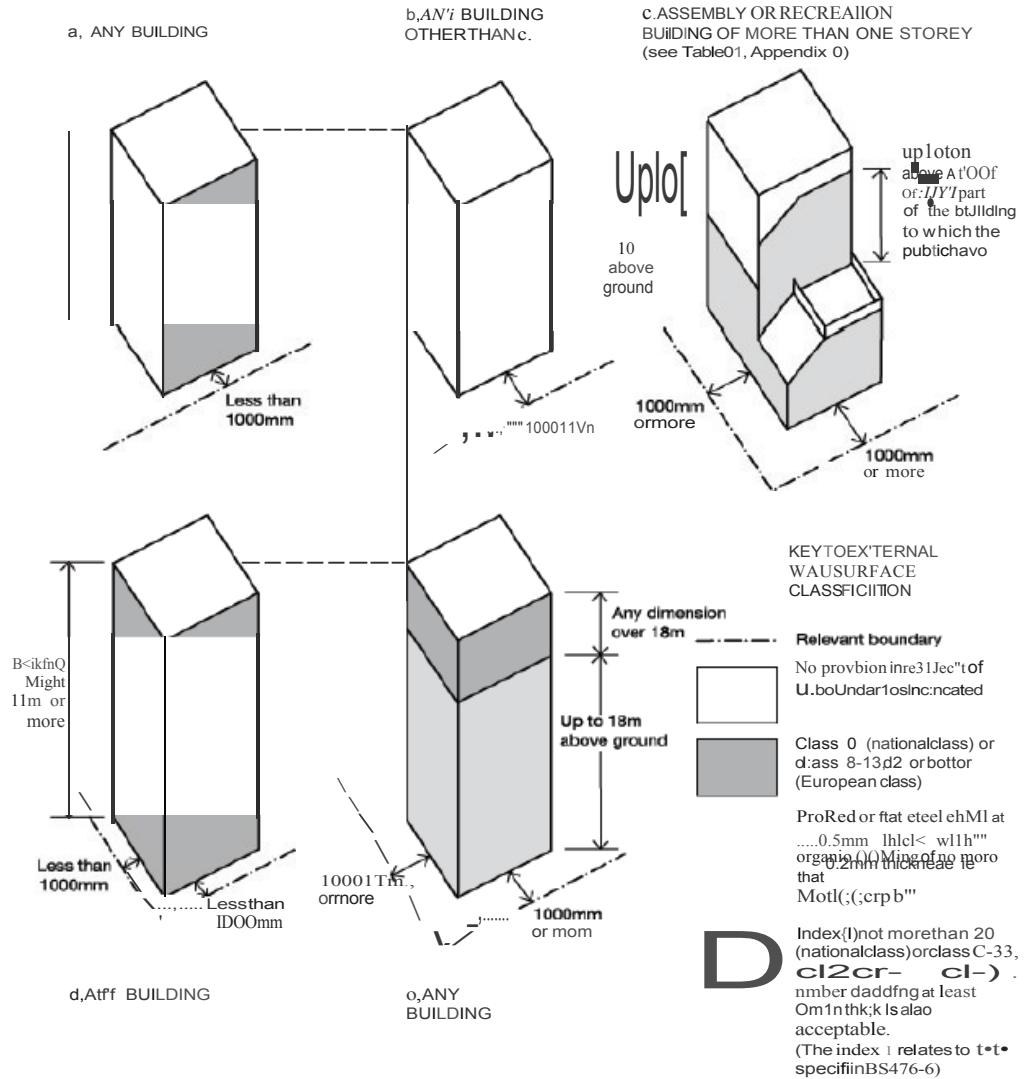
Diagram 40 Provisions for external surfaces or walls

See para 13.5 and 13.6

- 4.26 In Scotland in a building with any storey at a height of more than 18m above the ground, any insulation material situated or exposed in a cavity formed by external wall cladding should be non-combustible. However it should be noted that the definition of non-combustible under the guidance in Scotland is a material which complies with European Class A2-s3,d2 or better.
